WEST VALLEY
STRUCTURAL CO.

Property Inspection Report

407 Sample Ave, Millbrae, CA 94030

Date of Inspection: 10/19/2022 Time: 9:00 AM

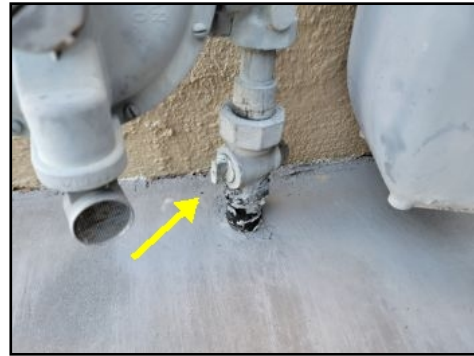
Main gas shut off valve.

Recommend contacting the Local Utility company to service the Gas meter and related components as needed this is mentioned as information only and is considered part of normal maintenance.

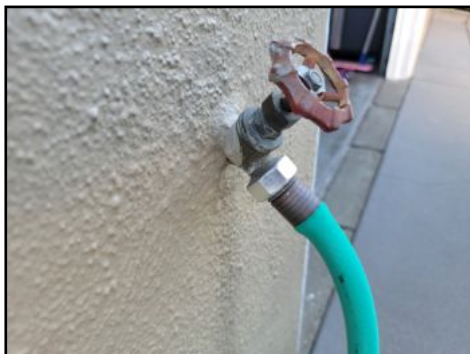
Hose bib(s) not equipped with anti-siphon devices, possible cross-contamination. Recommend licensed plumber install as needed.

Appears to be leaking at valve seal when in the open position, recommend repair for water conservation and to prevent possible water damage to structure/water intrusion if the hose is left on for extended period.

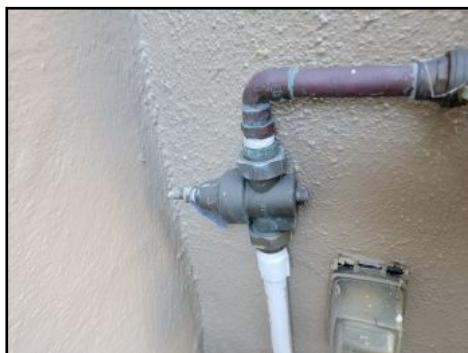
Pressure regulator noted.

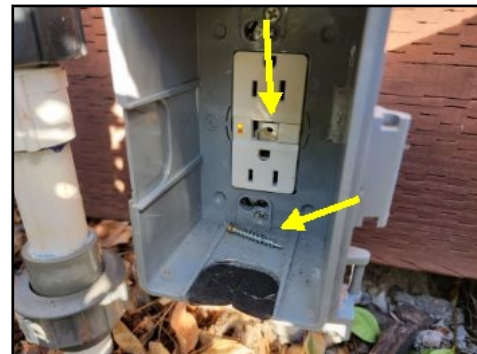
Damaged receptacles was noted at the time of inspection (rear of the home), recommend repairing/ improving as needed.

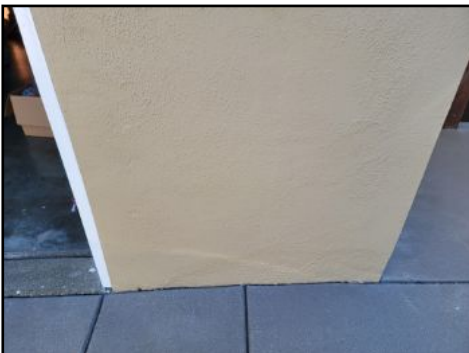
Stucco siding was missing a proper weep screed this is noted as a typical condition for homes of this area and of this age and is mentioned as information only.

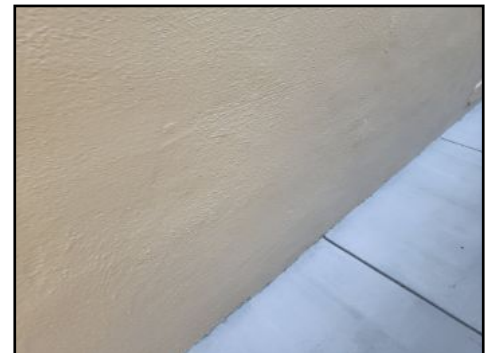
Exterior stucco showed signs of typical cracking and/ or sealed cracks recommend sealing/ monitoring/ repairing/ replacing as needed.

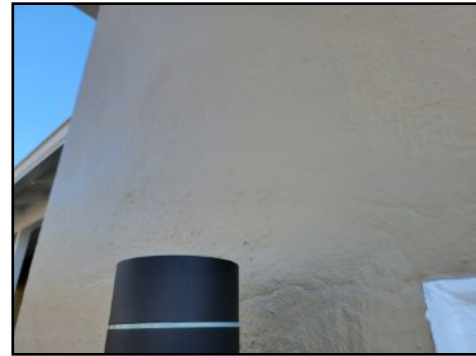
Exterior stucco showed signs of typical cracking and/ or sealed cracks recommend sealing/ monitoring/ repairing/ replacing as needed.

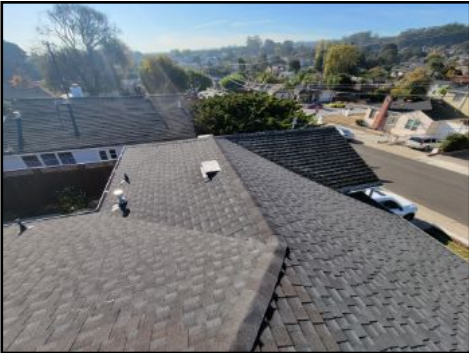
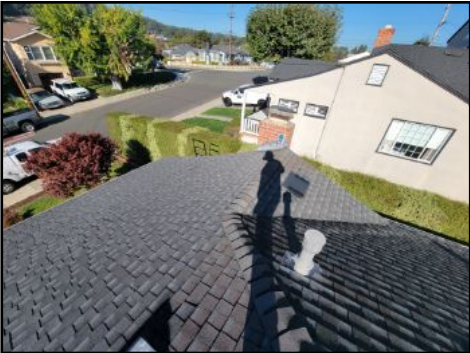
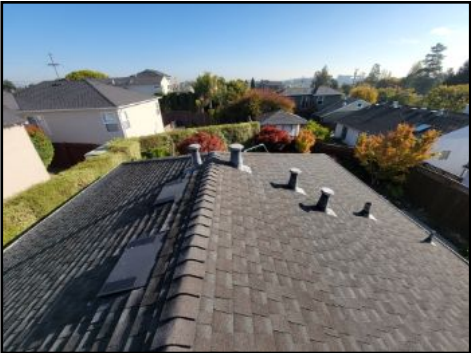
- Roof was older and appeared to be approaching the end of its life span, even though the roof was older it was in adequate condition for its age. We do recommend budgeting for a update within the next 10 years. Roof replacement is noted as a differed cost.
- Exposed nails on roofing material. Recommend sealing all fastener heads.
- Recommend cleaning moss/ vegetation/ debris off of the roof top as needed.

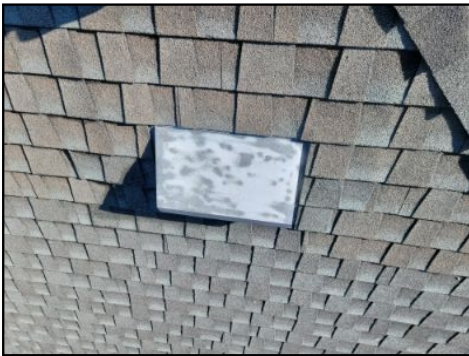
Recommend re-sealing and painting flashing/ vents as needed this recommendation is part of normal maintenance.

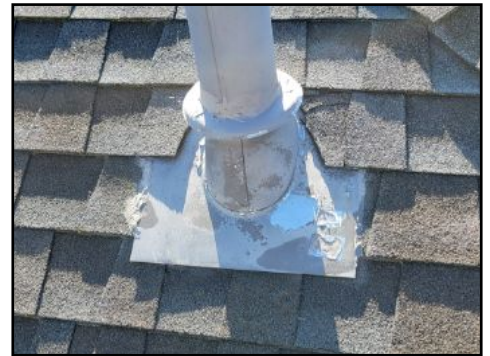
Recommend re-sealing and painting flashing/ vents as needed this recommendation is part of normal maintenance.

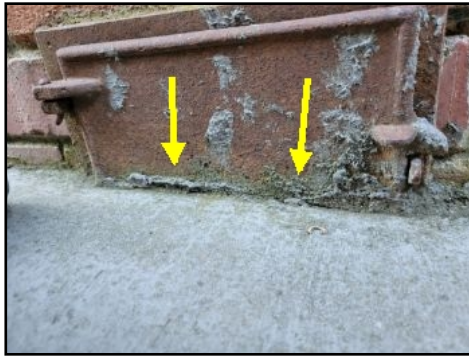
The chimney clean out was below the grade of the exterior concrete and/ was obstructed by the concrete. We recommend proving the proper clearance so the clean out door can be operated and/ or we recommend replacing clean out door with a door/ hatch that operates within this space/ area.

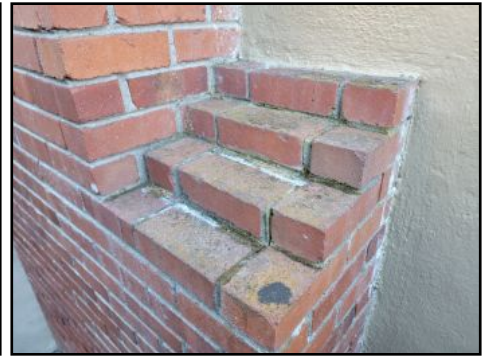
Recommend cleaning moss/ mold off of the chimney wall as needed.

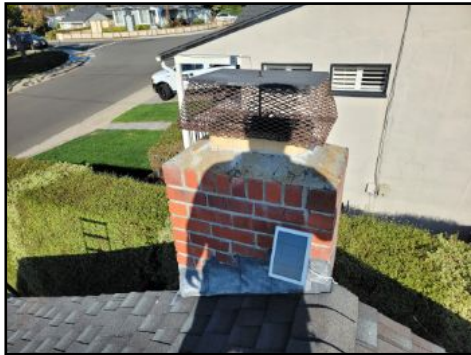
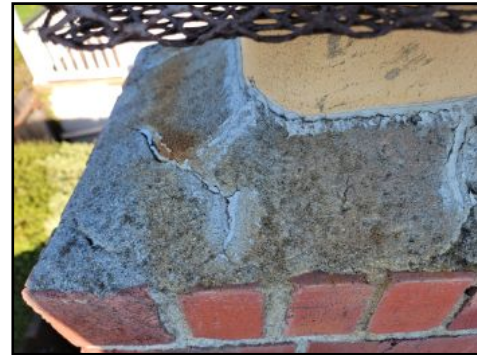
We recommend contacting a licensed chimney contractor to re-evaluate/ service/ clean prior to any use of the fireplace.

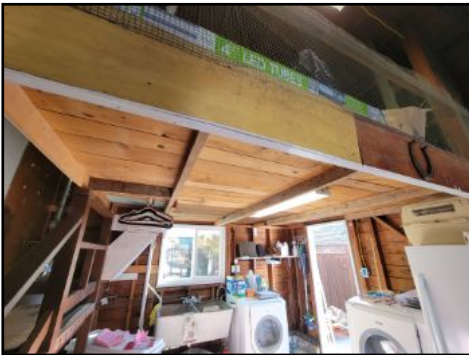
Please be advised the general installation/ construction of the storage/ mezzanine was noted as poor/ substandard (joist spacing are spread out to far apart/ incomplete joist length/ poorly hung - supported at the wall/ subfloor material is noted inadequate) we recommend not storing many items of heavy items until a licensed contractor further reviews and repairs/ improves as needed.

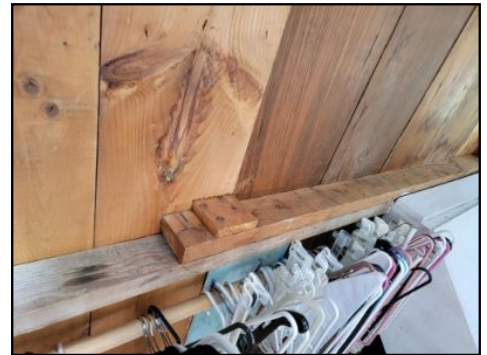
Please be advised the general installation/ construction of the storage/ mezzanine was noted as poor/ substandard (joist spacing are spread out to far apart/ incomplete joist length/ poorly hung - supported at the wall/ subfloor material is noted inadequate) we recommend not storing many items of heavy items until a licensed contractor further reviews and repairs/ improves as needed.

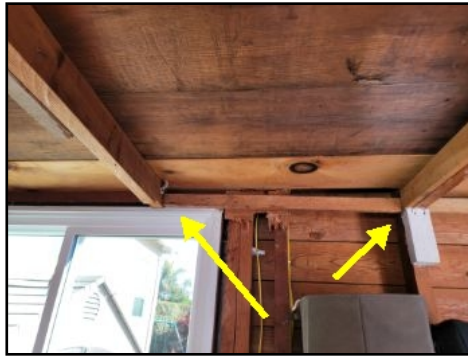
Please be advised the general installation/ construction of the storage/ mezzanine was noted as poor/ substandard (joist spacing are spread out to far apart/ incomplete joist length/ poorly hung - supported at the wall/ subfloor material is noted inadequate) we recommend not storing many items of heavy items until a licensed contractor further reviews and repairs/ improves as needed.

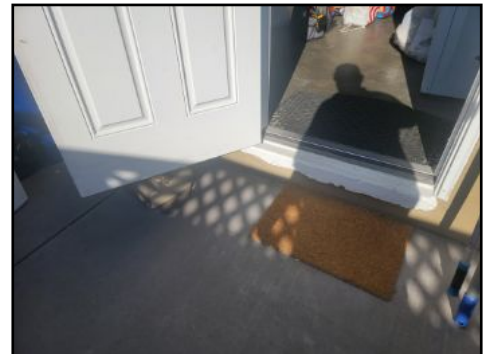
We noted a door which opened directly to a step; this installation is noted as a potential safety hazard/ concern. A door should not open to a step and should open to a landing/ flat area. We recommend changing door swing or contact a licensed professional to repair/ replace as needed.

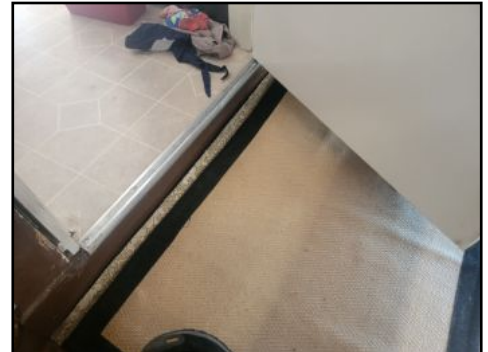
We noted a fire door which opened directly to a step; this installation is noted as a potential safety hazard/ concern. A door should not open to a step and should open to a landing/ flat area. We recommend contacting a licensed professional to repair/ replace as needed

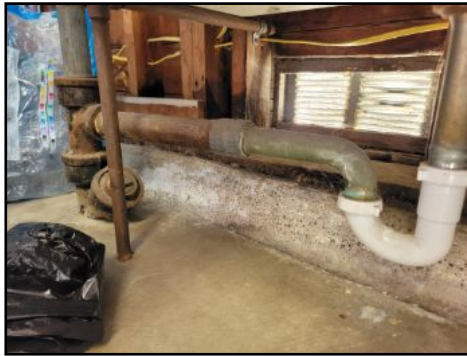
Recommend updating/ monitoring - corroded drain/ water supply lines as needed.

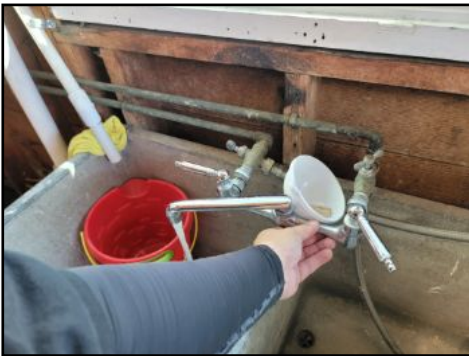
Sink faucet was loose, suggest securing as necessary.

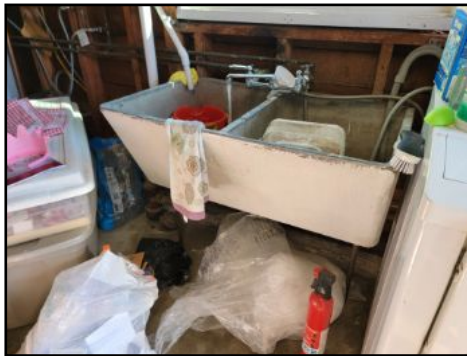
Sink was cracked, recommend repairing/ replacing as needed.

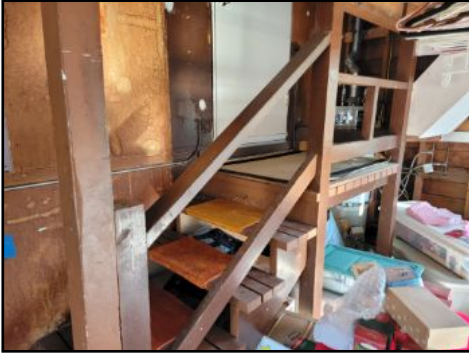
Balusters are over 4 inches apart, dangerous to children repair/ replace as needed.

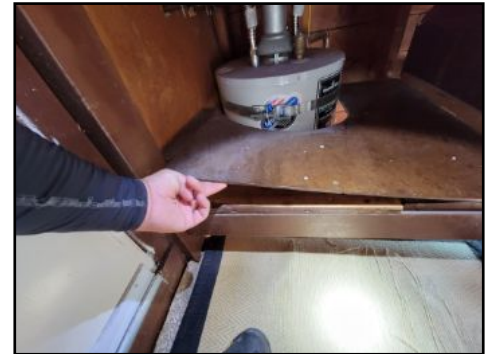
The upper landing was poorly installed or installed in a substandard manner (built around water heater/ landing does not have proper measurements), recommend improving/ replacing as needed.

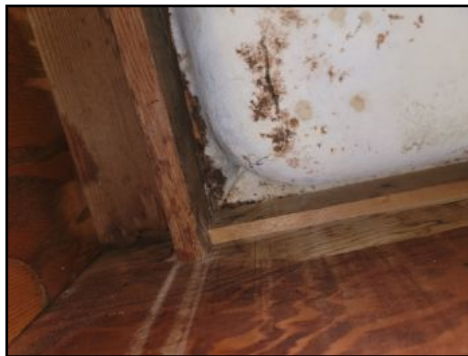
Sink rusted. Monitor for developing leaks (none found during inspection).

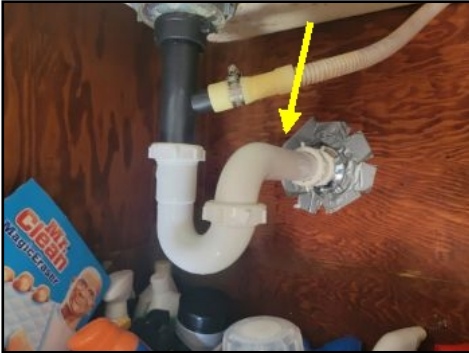
Drain line was incorrectly sloped and/ or noted as sub-standard installation recommend properly repairing/ replacing as needed.

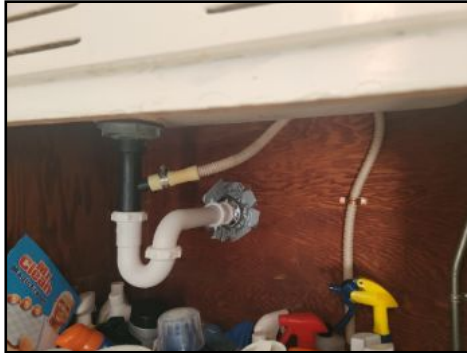
Please be advised there are no water shut off valves located below the sink, this is noted as a typical condition for homes of this age and this area. We recommend improving as needed.

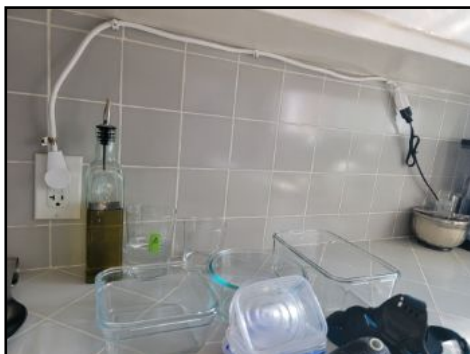
Minimal amount of receptacles were present at the time of inspection this is a common condition for homes of this age and in this area recommend considering adding/ improving as needed. Improving this condition will prevent or help prevent the need of extension cords.

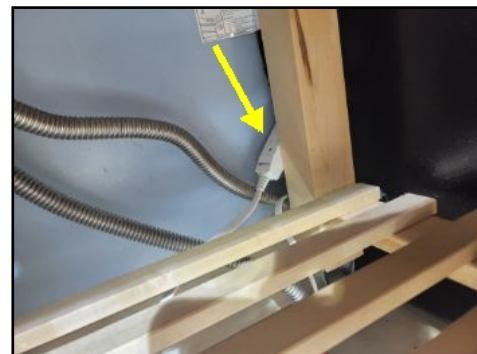
Extension cord wiring was noted this appears to be due to the lack of receptacles/ outlets present at the time of inspection. We recommend contacting a licensed professional to improve as needed. Extension cord wiring is noted as a potential safety concern.

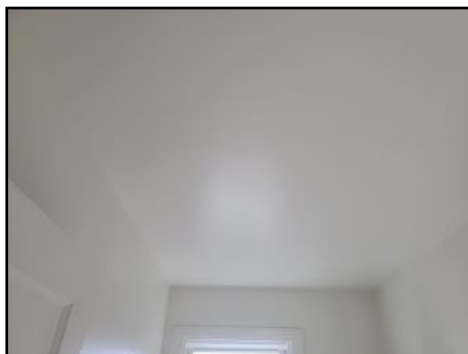
No fan was observed, we recommend an exhaust fan be installed in all bathrooms for proper ventilation and moisture control.

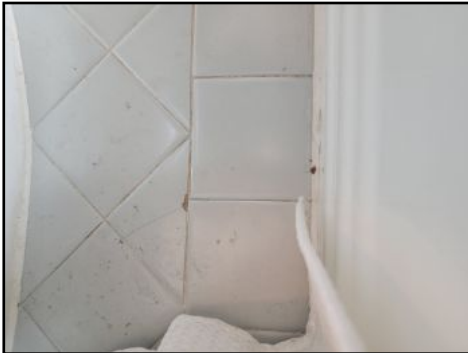
Cracked tiles noted.

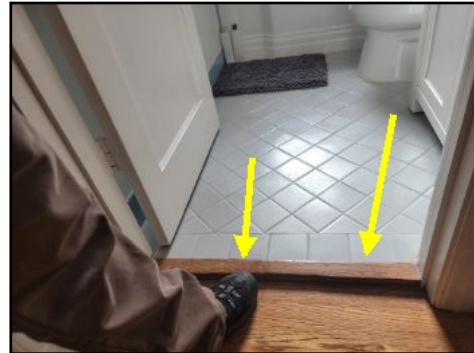
Threshold type at the hallway bathroom was noted as a potential trip hazard, we recommend improving/ updating as needed.

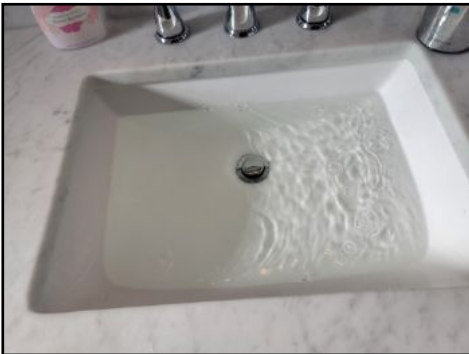
Drain showed signs of minor back up at the time of inspection recommend repairing/ replacing as needed.

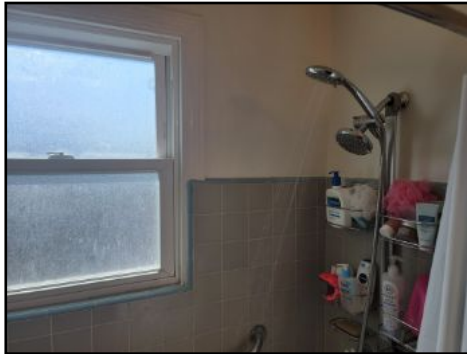
Window height in the tub/ shower area was noted as sub-standard/ low this condition may lead to potential water intrusion/ damage recommend monitoring/ updating/ repairing/ replacing as needed.

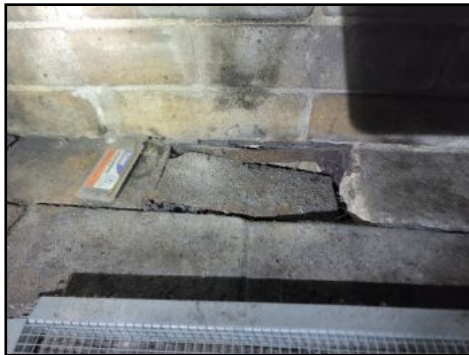
Recommend replacing damaged clean out cover as needed.

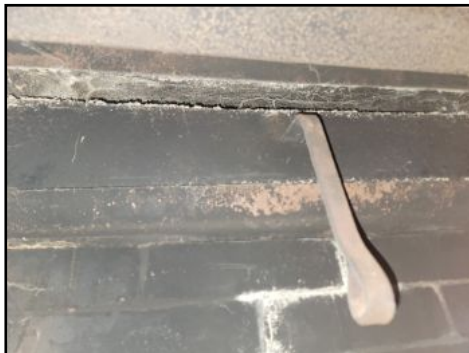
The damper was not properly operating and/ or the damper was damaged we highly recommend contacting a licensed chimney contractor to repair/ replace as needed.

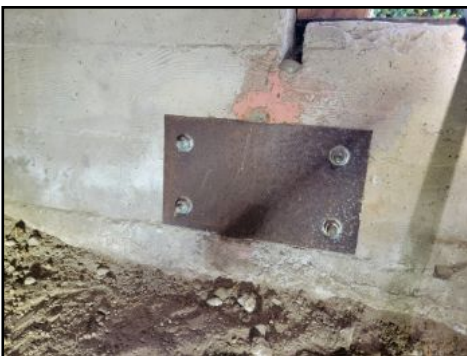
We noted evidence of repaired/ improved cracked areas to the foundation wall. Repairs appeared to be in overall adequate condition however we do recommend reviewing disclosure/ permit history to understand what was done, and by who. This is noted as a general observation/ recommendation.

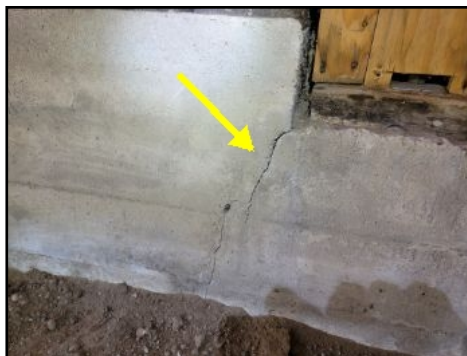
Cracks / Holes (1/4" or less) present in: foundation / floor / ext. wall. Consider sealing them to prevent water infiltration. Generally speaking, cracks that are less than 1/4" are not commonly regarded as being structurally significant.

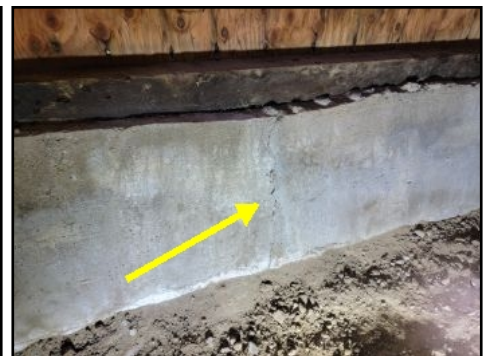
Cracks / Holes (1/4" or less) present in: foundation / floor / ext. wall. Consider sealing them to prevent water infiltration. Generally speaking, cracks that are less than 1/4" are not commonly regarded as being structurally significant.

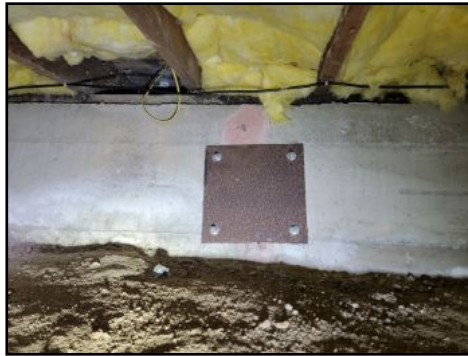
We noted evidence of repaired/ improved cracked areas to the foundation wall. Repairs appeared to be in overall adequate condition however we do recommend reviewing disclosure/ permit history to understand what was done, and by who. This is noted as a general observation/ recommendation.

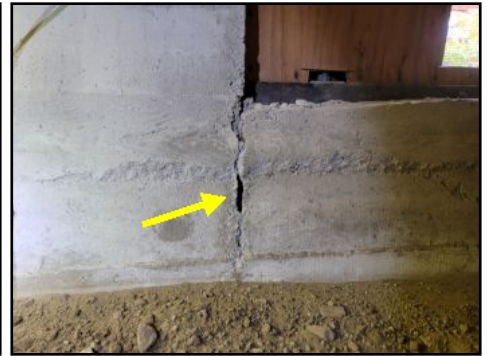
Cracks / Holes (1/4" or less) present in: foundation / floor / ext. wall. Consider sealing them to prevent water infiltration. Generally speaking, cracks that are less than 1/4" are not commonly regarded as being structurally significant.

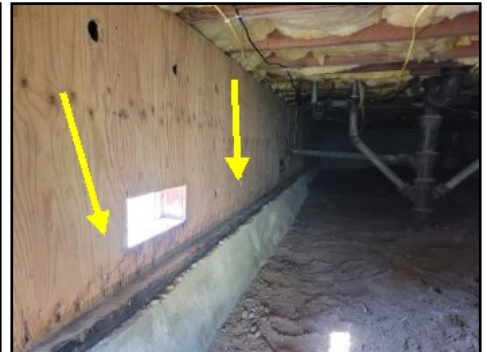
Moisture stains were noted to the shear wall paneling, however, no active leaks noted at the time of inspection recommend monitoring/ repairing/ replacing as needed.

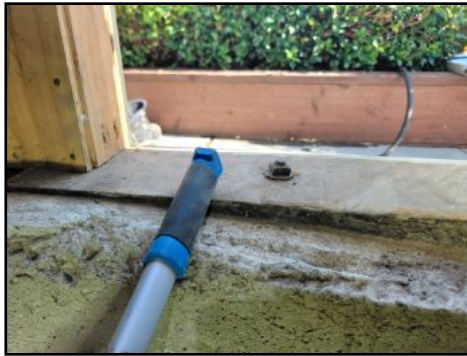
Some of the bolting was outdated.

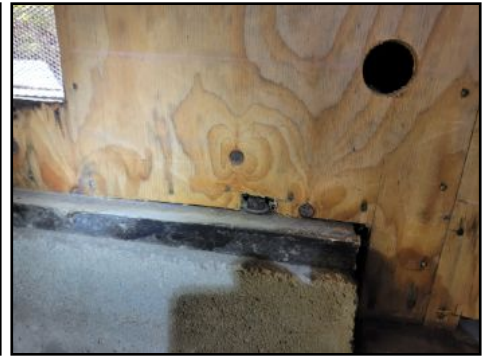
Some of the bolting was outdated.

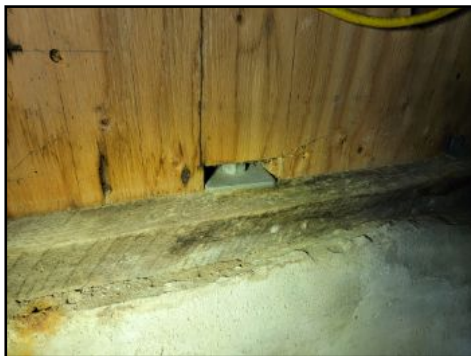
We noted evidence of repaired/ improved anchor bolts/ seismic restrain in the subarea repairs/ improvements appeared to be in overall adequate condition however we do recommend reviewing disclosure/ permit history to understand what was done, and by who. This is noted as a general observation/ recommendation.

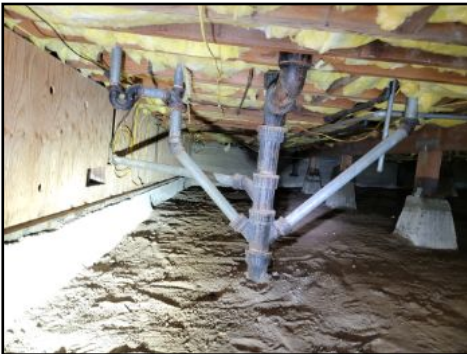
Recommend updating corroded/ leaking drain/ water supply lines as needed.

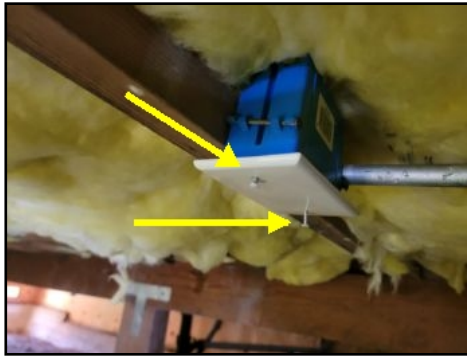
Recommend properly cover plate screws as needed.

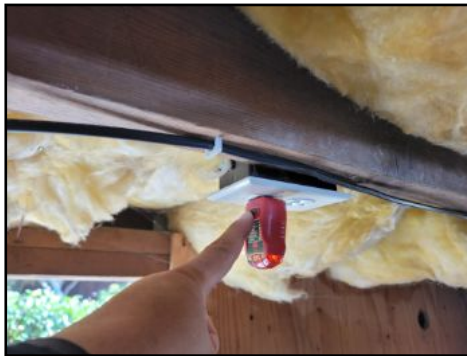
Recommend GFCI protection for all receptacles located in the crawlspace/ unfinished basement as needed.

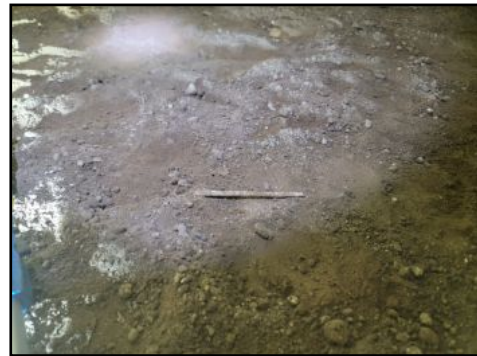
House hold pest type activity was noted in the crawlspace/ floor recommend contacting a licensed Pest Control Operator to mitigate/ clean infestation as needed. Recommend cleaning all debris from the crawlspace floor as needed.

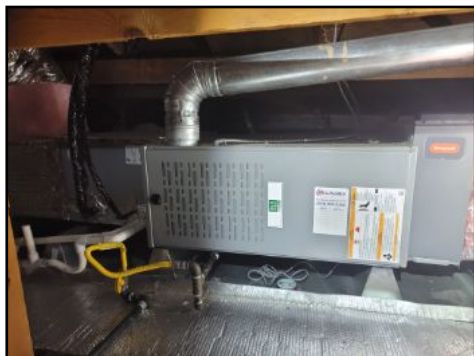
Furnace was in overall normal operating condition however we recommend contacting a licensed HVAC contractor to repair/ service the unit prior to normal use.

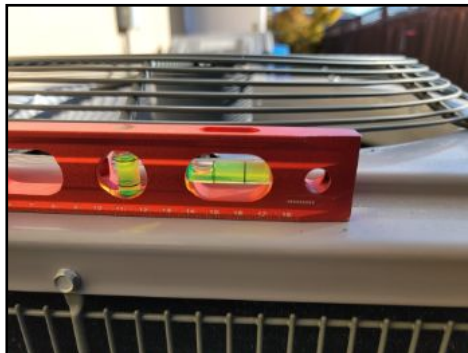
Air Conditioning mounting pad not level; this may shorten motor life. Suggest leveling pad or unit.

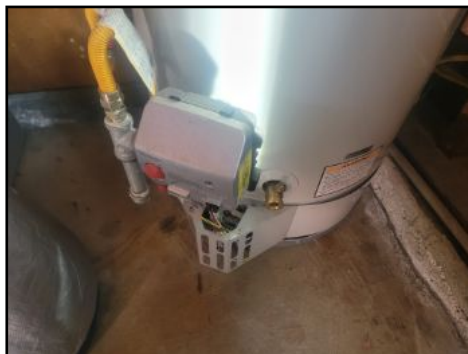
Recommend adding a drain pan to the water heater as needed.

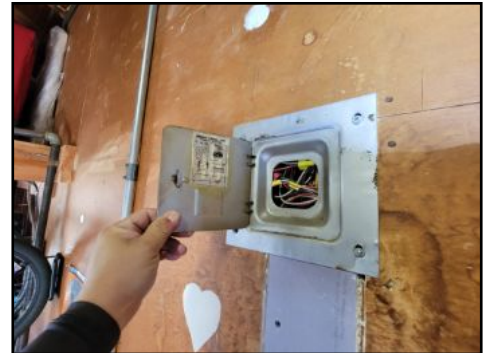
Please be advised we observed older panels in the garage which were converted to junction boxes. This is noted as a typical alteration however the old panels should be labeled as junction boxes and the covers need to be properly secured (screw). The current condition of these units are noted as a potential safety hazard (not labeled, cover not secured) recommend improving/ updating as needed.
