# WOOD DESTROYING PESTS AND ORGANISMS INSPECTION REPORT

Building No. 407	Street Sample Ave	City Millbrae	ZIP 94030	Date of Inspection 12/20/2022	Number of Pages 6
---------------------	----------------------	------------------	--------------	----------------------------------	----------------------

<b>West Valley Structural Corp.</b> P.O. Box 2 So. San Francisco CA 94083 (650) 737-0527 (510) 552-7420 chester@westvalleyinspections.com	Report # : 11944 Registration # : PR8445 Escrow # : <input type="checkbox"/> CORRECTED REPORT
--	---	--

This is a supplemental report to original report dated 10/19/2022, report #11910.

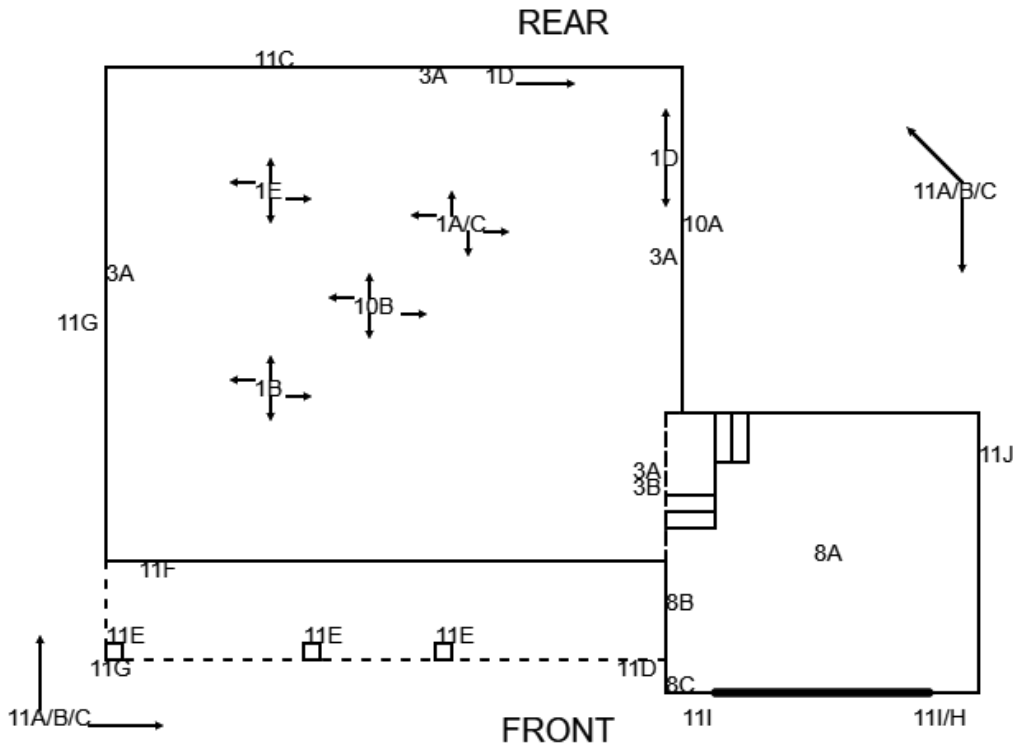
### Diagram Not To Scale

**FINDING:** Evidence of Subterranean Termites (tubes) to the wall sheathing where shown in the diagram.

**FINDING:** The base of the siding is damage by fungus as shown in the diagram.

**FINDING:** Fungus has damage the rafter tail where shown in the diagram.

**FINDING:** Dampwood Termite (dead swarmer) was spotted by the exterior wall shown in the diagram. At the present time we noted no evidence of damage or infestation.

**FINDING:** Fungus damage the side exterior service door jambs absorbing at the approximate area shown in the diagram.

**RECOMMENDATION:** For control of Subterranean Termites chemically treat the local soil (from interior or exterior) at probable entry points using termiticide Premise-75 per label instructions while the dwelling is vacated during eight hours period for application and aeration procedure.

**RECOMMENDATION:** Cut the damaged siding and repair with new siding of similar design. Primer only.

**RECOMMENDATION:** From below cut the damaged rafter and repair with new wood according local building code. Primer only.

**RECOMMENDATION:** Periodic monitoring and inspection recommended.

**RECOMMENDATION:** Cut the damaged portion and fill the void with mortar cement or repair with new wood (filler) without perfect match. Primer only.
