Property Inspection Report

849 Sample St , San Francisco , CA 94114 Inspection prepared for: Real Estate Agent: Sample Sample - Sample Real Estate

Date of Inspection: 10/18/2022 Time: 1:00 PM Age of Home: Built 1960/ 62 Years of Age Size: Approx: 4,854 Sq. Ft. Inspector: Chester R. Gavarrete Jr.

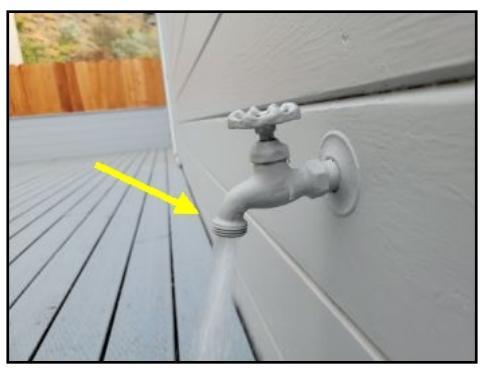
Appears to be leaking at valve seal when in the open position, recommend repair for water conservation and to prevent possible water damage to structure/water intrusion if the hose is left on for extended period.

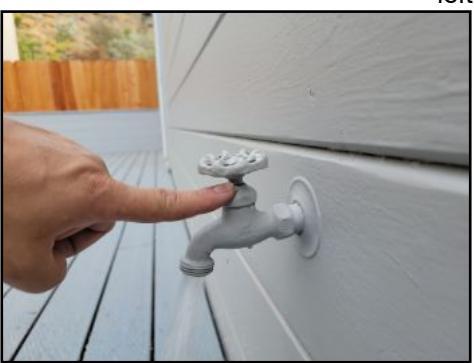
Hose bib(s) not equipped with antisiphon devices, possible crosscontamination. Recommend licensed plumber install as needed.

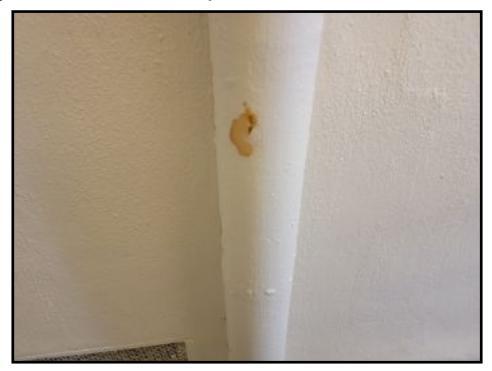
Rust and minor leaking was noted to the grounds plumbing components recommend contacting a licensed plumber to service/ repair/ replace as needed.

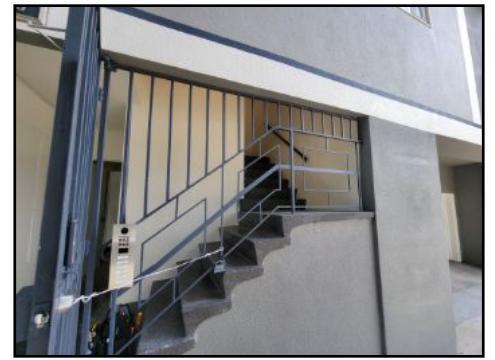
Railing and/ or certain sections of railings were not equipped with a proper graspable handrail/ grab bar; this condition is noted as a common condition, however, it is noted as a potential safety hazard/ concern we recommend considering improving as needed.

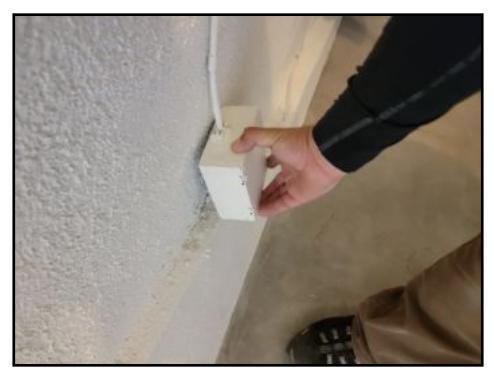
Electrical box was loose recommend properly installing/ repairing/ replacing as needed.

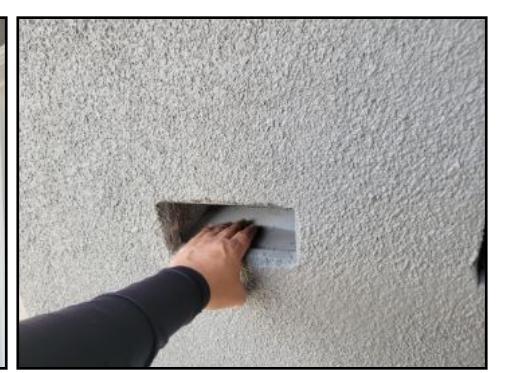
Recommend replacing missing utility opening window pane(s) as needed.

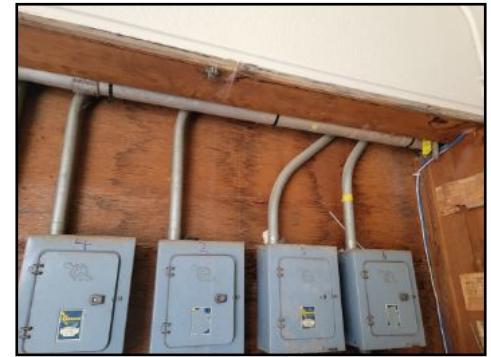
Moisture stains were noted within the electric panel utility closet; we recommend monitoring this area during inclement weather and repairing/ replacing as needed.

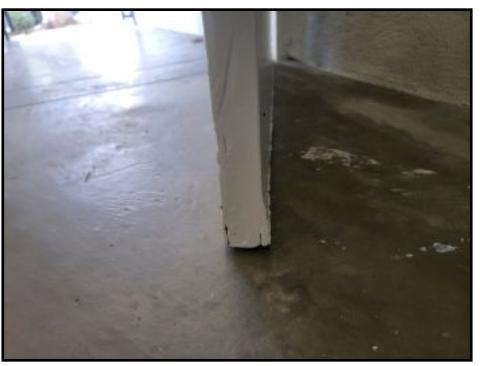
Exterior door showed signs of rotted/ for additional information/ recommendations.

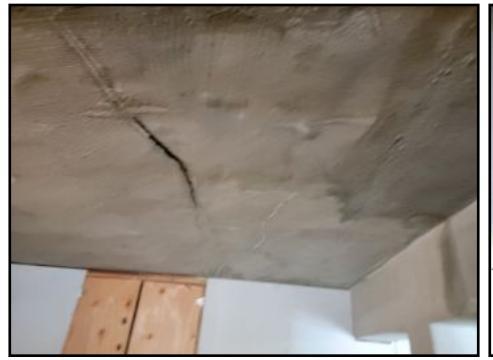
Typical cracking was noted to the wall covering and/ or ceiling recommend repairing/ replacing as needed.

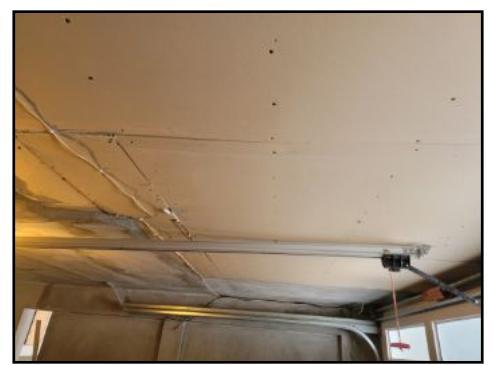
The common wall between the garage and home has damage or improper covered areas. Fire potential to the home is at a greater risk. Recommend repairing or installing the proper fire rated wall.

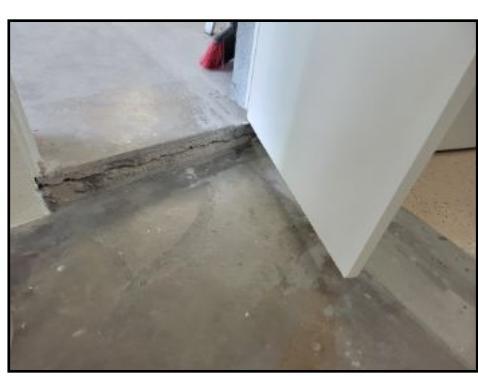
The door is not fire rated this is noted as a SAFETY HAZARD.

We noted a fire door which opened directly to a step; this installation is noted as a potential safety hazard/ concern. A door should not open to a step and should open to a landing/ flat area. We recommend changing the swing of the door or contact a licensed professional to repair/ replace as

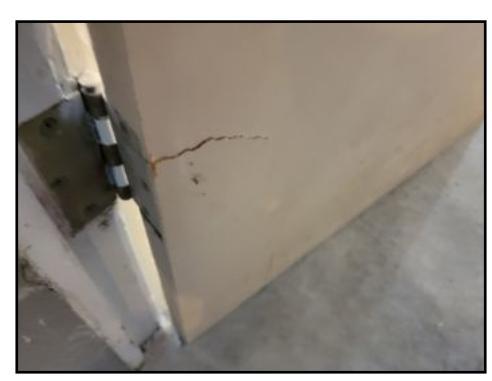
The door is not fire rated this is noted as a SAFETY HAZARD.

The door is damaged, recommend repairing/ replacing as needed. Recommend replacing with a Fire Rated door.

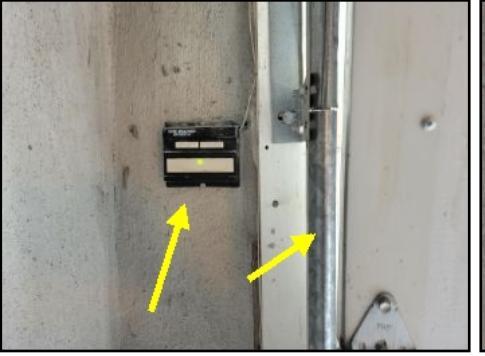
Garage door remote was placed adjacent to the garage door guides/ rails this is noted as a potential safety hazard repair/ replace as needed.

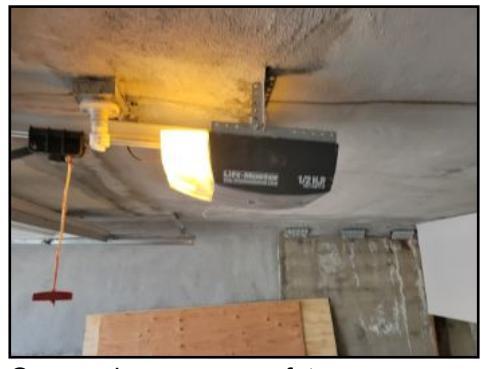
· Garage door opener safety reverse was not properly operating this is noted as a potential safety hazard recommend repairing/ replacing as needed.

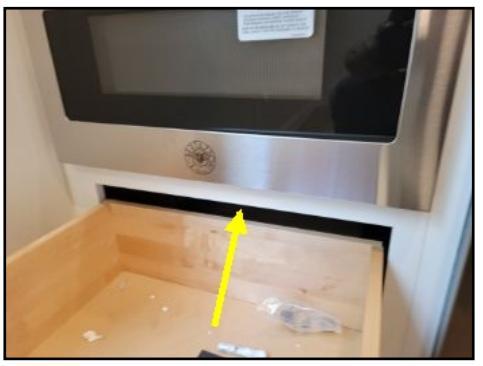
Recommend replacing the missing cover plate(s) as needed.

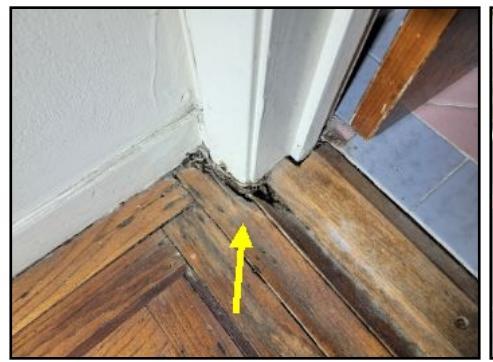
We noted evidence of water damage to We noted evidence of water damage to the flooring outside of the shower (tiled floor/ hardwood floor) refer to the WDO report for additional information and/ or recommendations as needed.

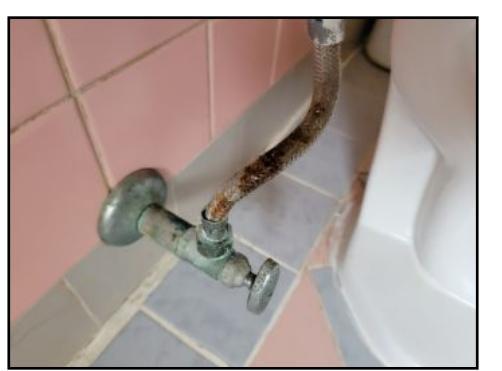
Corrosion/ rusting was noted around the plumbing lines/ components, however, no active leaks present at the time of inspection recommend monitoring/ repairing/ replacing as needed.

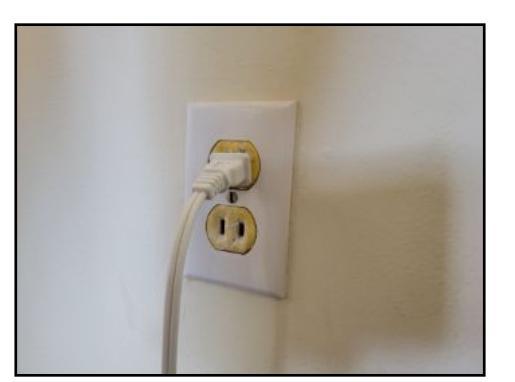
2-prong outlets - The home contained outdated, nongrounded 2-prong electrical outlets. Although this condition may have been commonly considered safe or acceptable at the time the home was originally constructed, as general knowledge of safe building practices has improved with the passage of time, building standards have changed to reflect current understanding. Consider updating the existing condition to meet generally-accepted current standards.

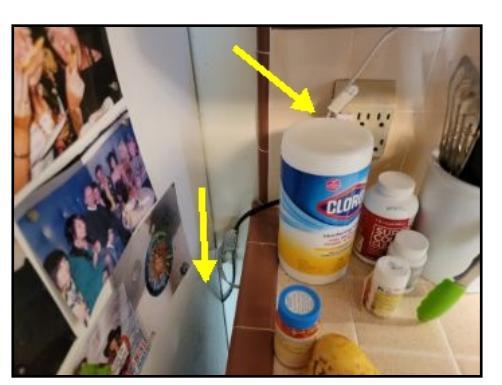
Please note the refrigerator was plugged into a outlet on the counter/ typically the appliance should have a outlet behind/ below the unit. We recommend contacting a licensed electrician to improve this installation as needed.

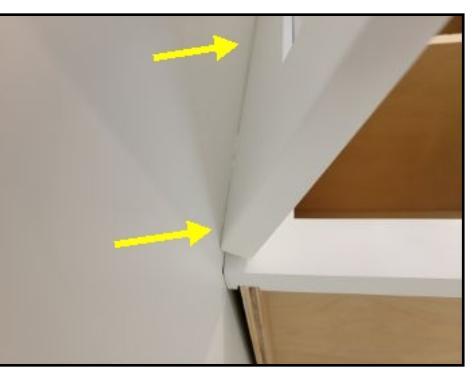
The cabinet door had minimal to poor clearance to the adjacent wall. We recommend monitoring this area and/ or adjusting/ repairing as needed.

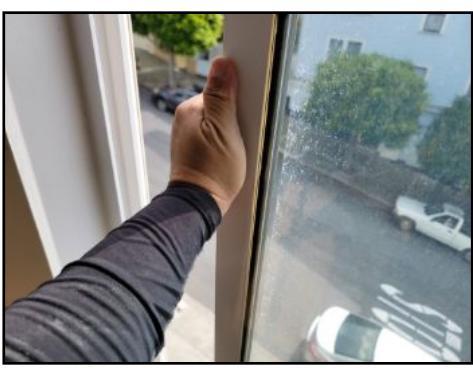
Please be advised we noted that the vinyl window sash/ frame has detached from the window pane, we recommend contacting a licensed window contractor to repair/ improve as needed.

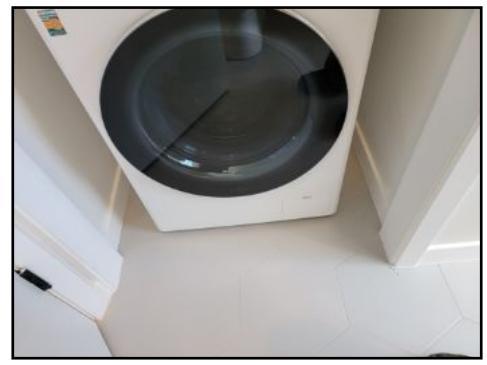
Recommend adding a drain pan for the washer appliance as needed.

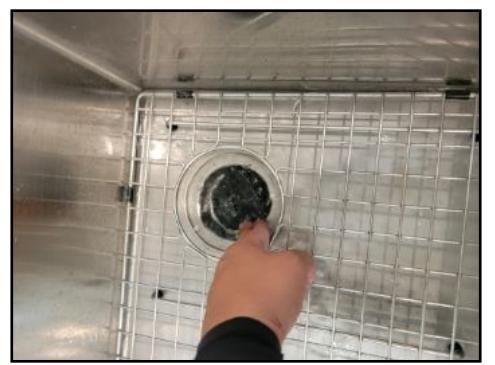
Drain showed signs of back up at the time of inspection recommend contacting a licensed plumber to repair/ replace as needed.

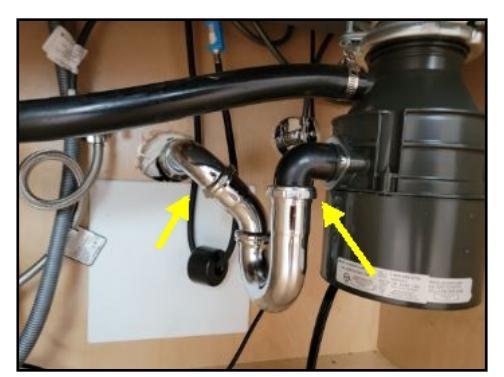
Drain installation was noted as overall poor/ sub-standard recommend contacting a licensed plumber to properly repair/ replace as needed.

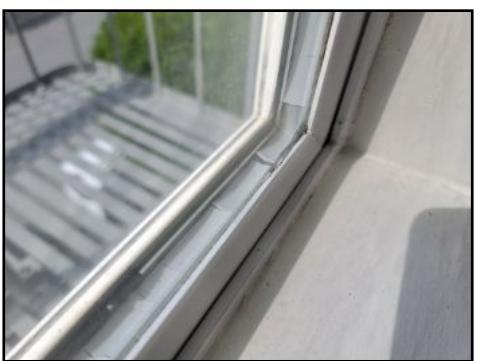
Certain windows showed signs of leaking insulated glass recommend to repair/ further evaluate as needed.

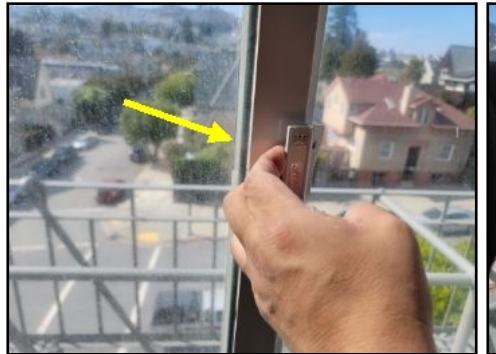
Please be advised we noted that the vinyl window sash/ frame has detached from the window pane, we recommend contacting a licensed window contractor to repair/ improve as needed.

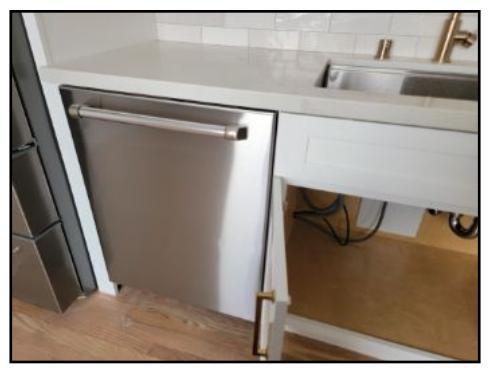
There was a air gap present on the counter however when Dishwasher was not operated this is due to the drain line not inspected from below we noted that the air gap was not connected and/ or not in use; recommend properly installing as needed.

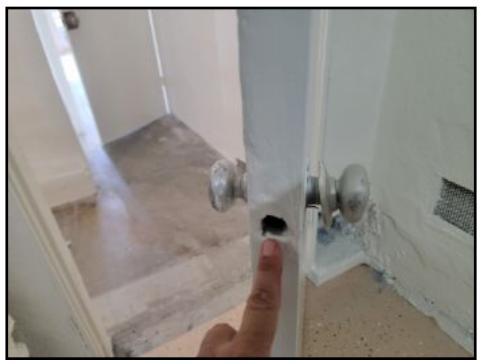
Door latch at the ground floor utility room was not properly operating, we recommend contacting a licensed professional to repair/ improve as needed.

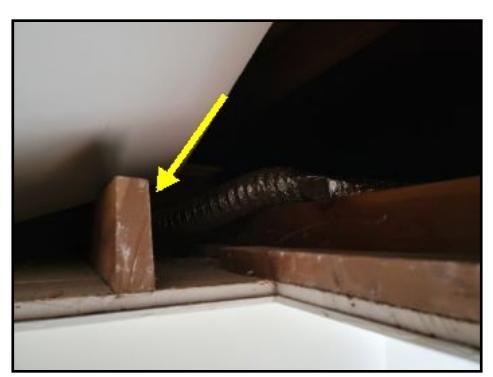
We noted that the ceiling joist were notched to create the attic access hatch opening, we recommend having a licensed professional improve reenforce the joist as needed. licensed professional improve reenforce the joist as needed. (recommend adding blocking as needed)

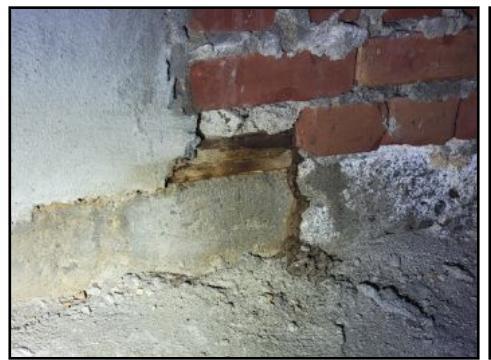
Evidence of WDO infestation was noted at the time of inspection refer to the WDO report for additional information and/ or recommendations as needed.

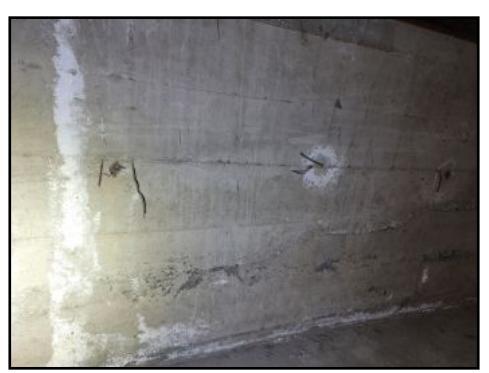
We observed form board nails present to the foundation wall recommend removing as needed.

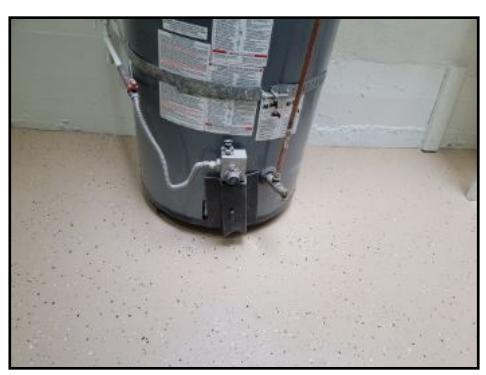
Recommend adding a drain pan to the water heater as needed.

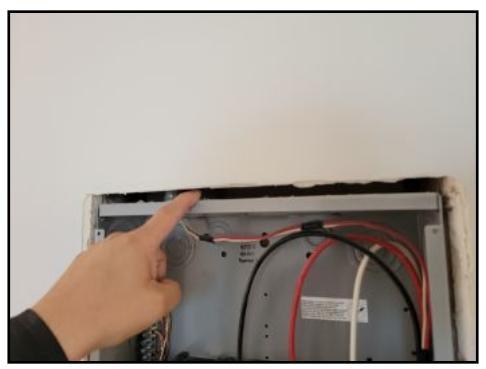
We noted excess gap between certain subpanels and the wall covering, we recommend improving/ repairing this installation as needed. Unit 3 Sub-Panel

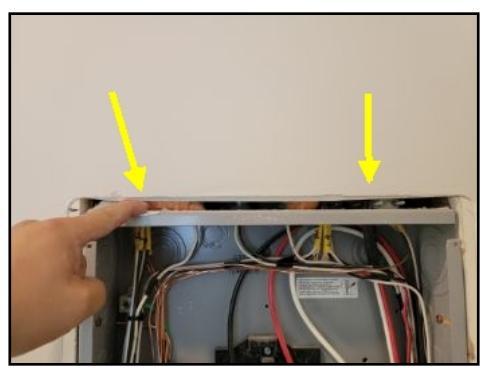
We noted excess gap between certain subpanels and the wall covering, we recommend improving/ repairing this installation as needed. Unit 5 Sub-Panel

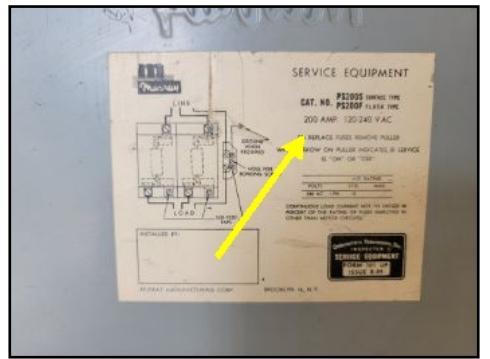
200 amp - Fuse - (Main Switch - Recommend having a licensed electrician further review and provide recommendations for repair/ update)
