WEST VALLEY
STRUCTURAL CO.

Property Inspection Report

407 Sample Ave, Millbrae, CA 94030

Date of Inspection: 10/19/2022 Time: 9:00 AM

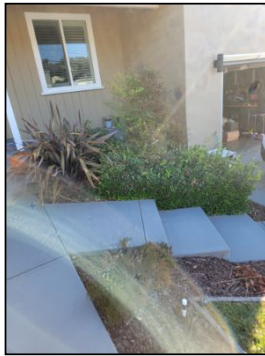
Attached planter box/es are noted as a WDO attraction point party of interest should consider removing as needed.

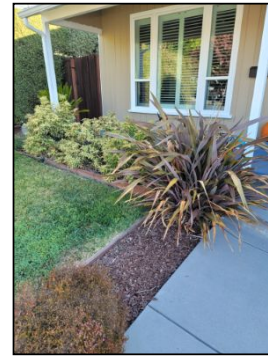
Maintenance Tip: When landscaping, keep plants, even at full growth, at least a foot (preferably 18 inches) from house siding and windows. Keep trees away from foundation and roof. Plants in contact or proximity to home can provide pathways for wood destroying insects, as well as abrade and damage siding, screens and roofs.

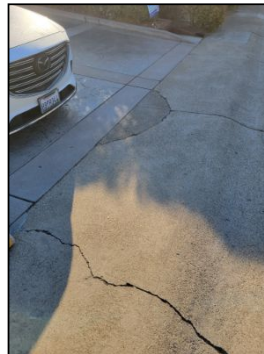
Typical cracking was noted to the driveway and/ or walkway repair/ replace as needed.

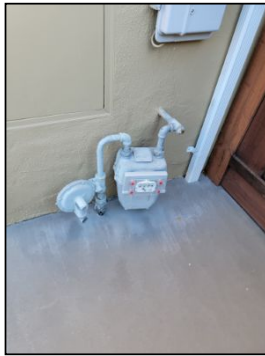
Recommend contacting the Local Utility company to service the Gas meter and related components as needed this is mentioned as information only and is considered part of normal maintenance.

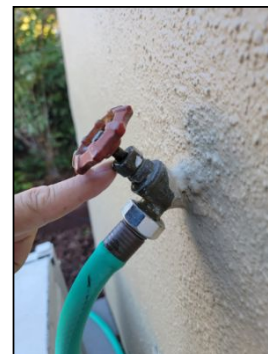
Appears to be leaking at valve seal when in the open position, recommend repair for water conservation and to prevent possible water damage to structure/water intrusion if the hose is left on for extended period.

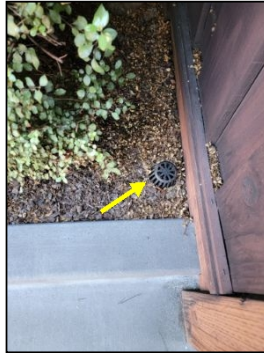
Recommend contacting a licensed plumber/ drainage contractor to service and test the exterior drains to confirm proper functionality.

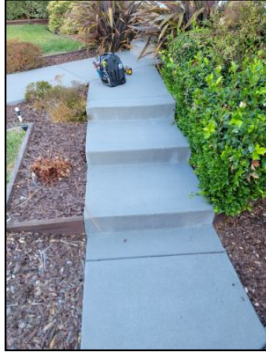
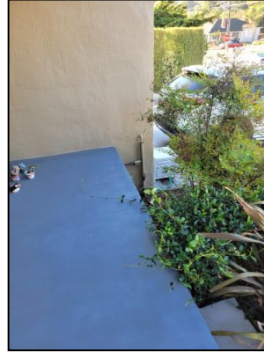
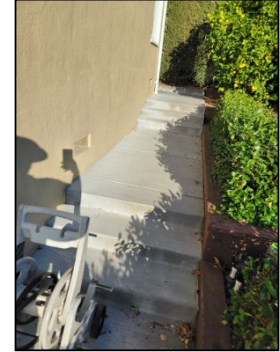
Although railings are not required with drop-offs less than 30" above grade and stairs with 3 or less risers - we recommend considering your own personal needs and those of your family and guests. By today's standards, balusters (spindles) at decks and steps should be spaced no more than 4" apart for the safety of small children,

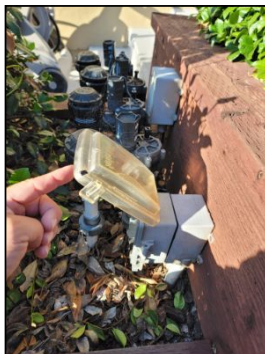
Damaged receptacles was noted at the time of inspection (rear of the home), recommend repairing/ improving as needed.

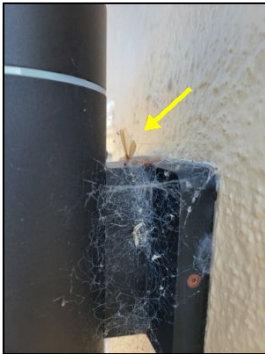
Evidence of damp wood termite swarmer (died) was noted at the front of the home (at light fixture), no evidence of active or damage was noted. We do recommend referring to the WDO report for additional information and/ or recommendation as needed.

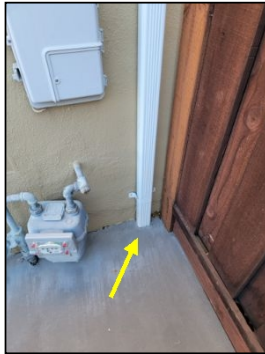
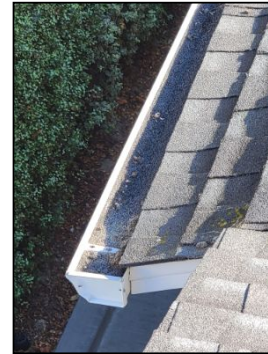
Recommend considering adding a clean out to the gutter drain as needed. Recommend properly cleaning/ servicing gutters as needed.

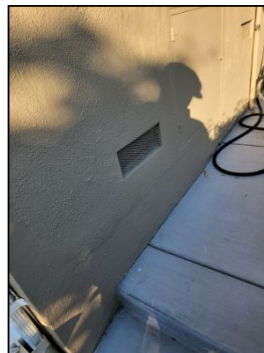
Stucco siding was missing a proper weep screed this is noted as a typical condition for homes of this area and of this age and is mentioned as information only.

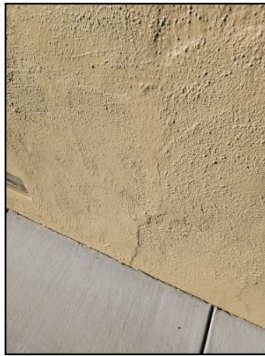
Exterior stucco showed signs of typical cracking and/ or sealed cracks recommend sealing/ monitoring/ repairing/ replacing as needed.

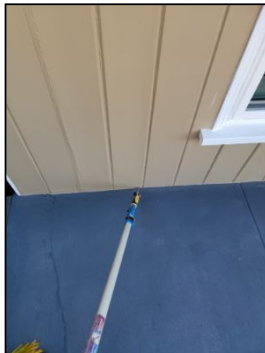
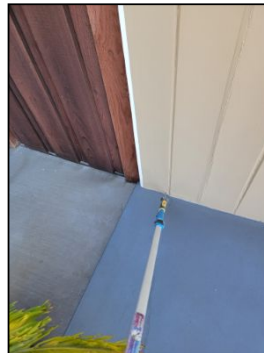
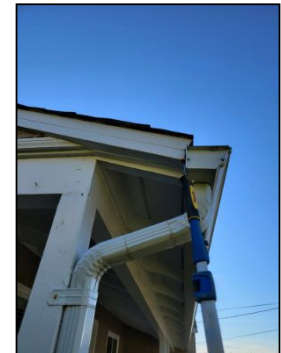
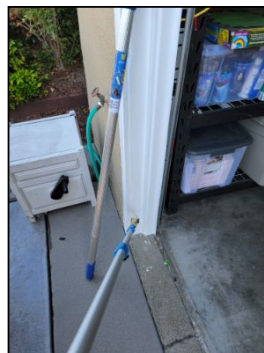
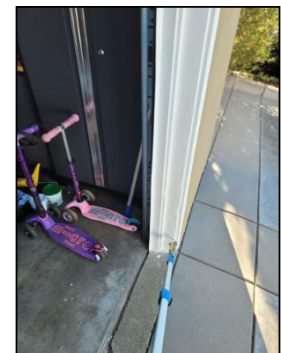
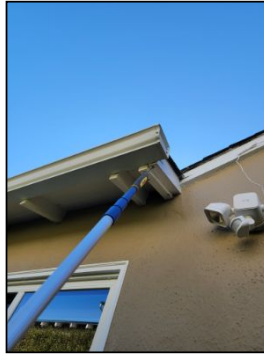
Rotted/ damaged wood noted at the time of inspection refer to the WDO report for additional information and/ or recommendations as needed.

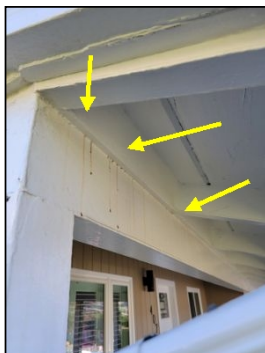
Moisture stains was noted to the trim/ girder below the roof in the front porch area, this maybe indicating a potential roof leak. We recommend monitoring and/ or repairing/ improving as needed.

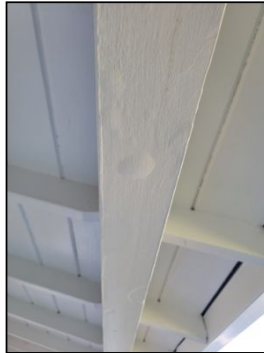
Bubbling paint observed, suggest scraping and painting as necessary.

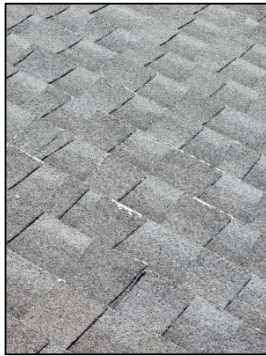
Roof was older and appeared to be approaching the end of its life span, even though the roof was older it was in adequate condition for its age. We do recommend budgeting for a update within the next 10 years. Roof replacement is noted as a differed cost.

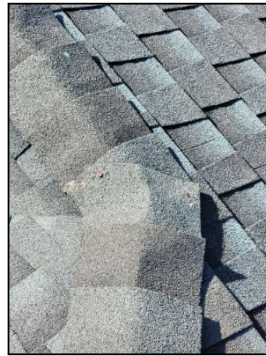
Exposed nails on roofing material. Recommend sealing all fastener heads.

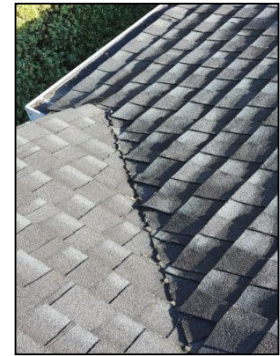
Recommend cleaning moss/ vegetation/ debris off of the roof top as needed.

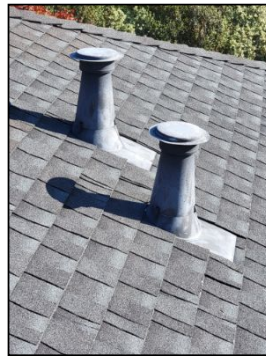
Typical maintenance necessary, now and on an annual or semi-annual basis. This generally consists of resealing gaps at through-the-roof projections and at the parapet walls as necessary.

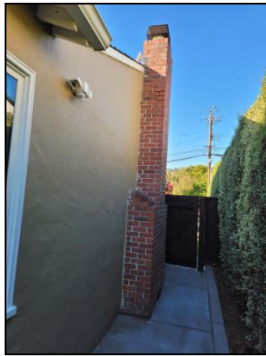
We recommend contacting a licensed chimney contractor to re-evaluate/ service/ clean prior to any use of the fireplace.

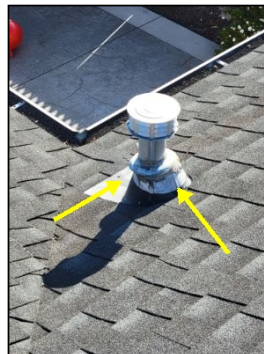
Water heater vent installation at the roof top was installed in a substandard manner, we recommend contacting a licensed professional to improve and/ or periodically maintain as needed.

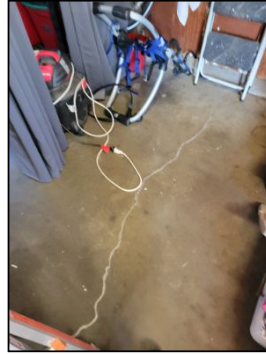
Typical cracks were noted to the garage floor recommend repairing/ replacing as needed.

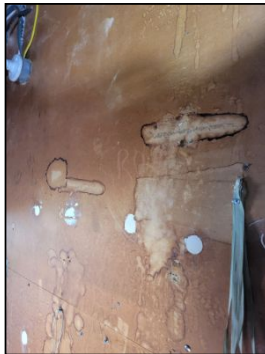
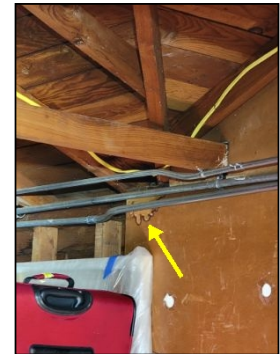
Moisture stains were noted to the wall covering, however, no active leaks noted at the time of inspection recommend monitoring/ repairing/ replacing as needed.

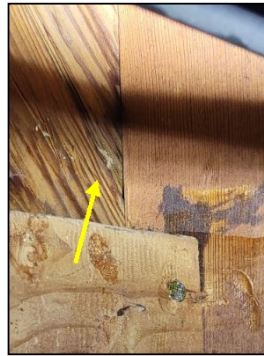
Evidence of WDO activity was noted at the time of inspection (subterranean termite activity), refer to the WDO report for additional information and/ or recommendations as needed.

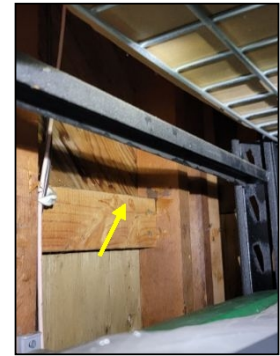
Evidence of WDO activity was noted at the time of inspection (subterranean termite activity), refer to the WDO report for additional information and/ or recommendations as needed.

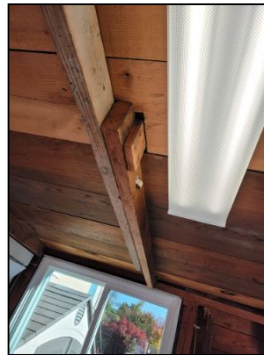
Please be advised the general installation/ construction of the storage/ mezzanine was noted as poor/ substandard (joist spacing are spread out to far apart/ incomplete joist length/ poorly hung - supported at the wall/ subfloor material is noted inadequate) we recommend not storing many items of heavy items until a licensed contractor further reviews and repairs/ improves as needed.

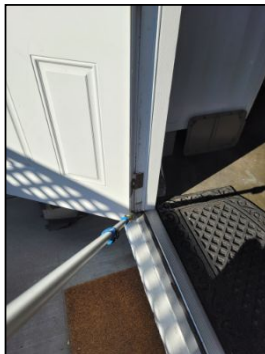
Garage service door showed signs of WDO damaged/ infestation refer to the WDO report for additional information/ recommendations.

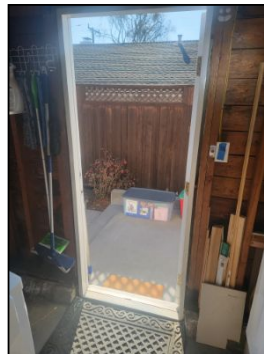
We noted a door which opened directly to a step; this installation is noted as a potential safety hazard/ concern. A door should not open to a step and should open to a landing/ flat area. We recommend changing door swing or contact a licensed professional to repair/ replace as needed.

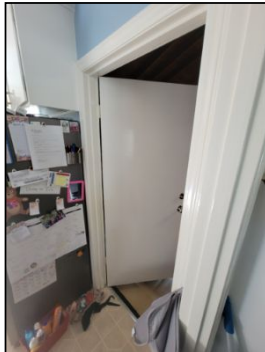
The door between the home and garage was missing proper fire door labeling unable to determine if this door is properly fire rated this is mentioned as information only.

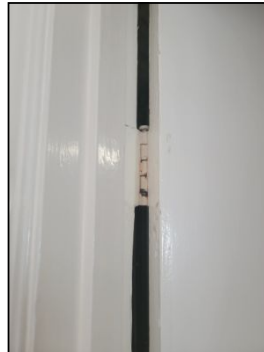
The automatic closure device is missing. This could allow a fire to enter the home and is considered a SAFETY HAZARD. Recommend contacting a licensed door contractor to repair/ replace as needed.

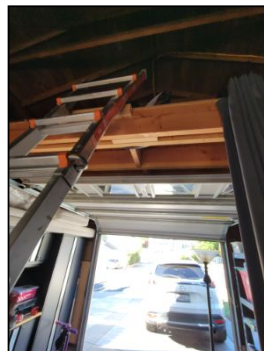
No garage door opener present at the time of inspection this is noted as information only.

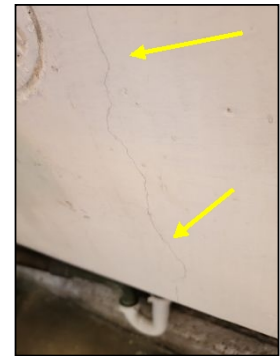
Sink was cracked, recommend repairing/ replacing as needed.

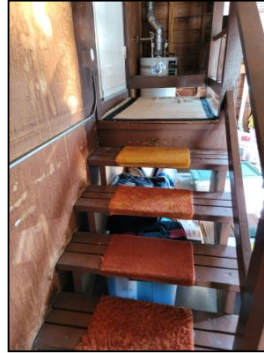
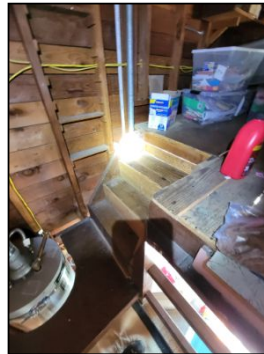
Grab bar/ railing was missing and/ or nonconforming this is noted as a potential safety hazard/ concern. We recommend contacting a licensed professional to repair/ improve as needed.

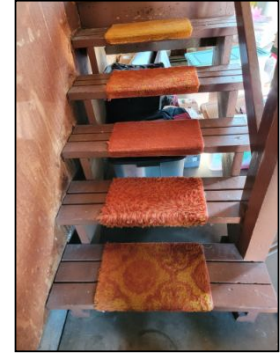
Recommend adding riser cover to improve general safety.

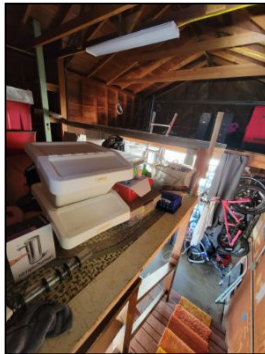
The upper landing was poorly installed or installed in a substandard manner (built around water heater/ landing does not have proper measurements), recommend improving/ replacing as needed.

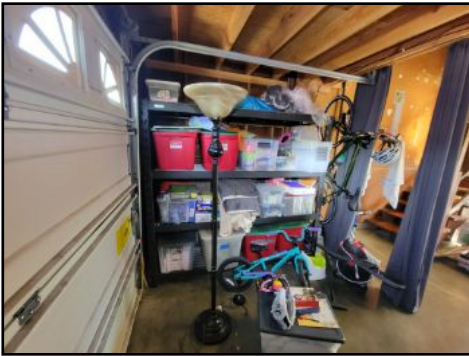
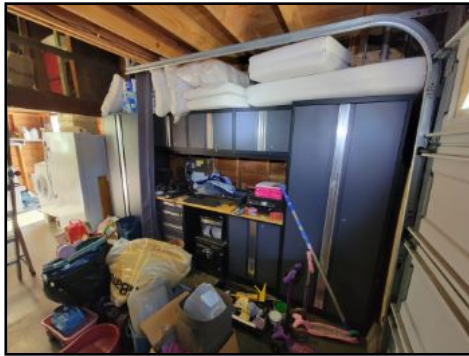
Garage inspection was very limited this is due to stored/ personal items blocking/ limiting access at the time of inspection recommend repairing/ replacing as needed.

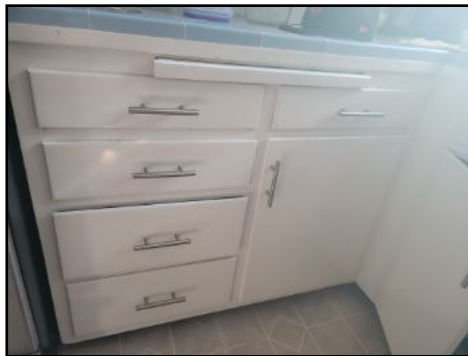
DEFERRED COST: The cabinets are original. Consider upgrade.

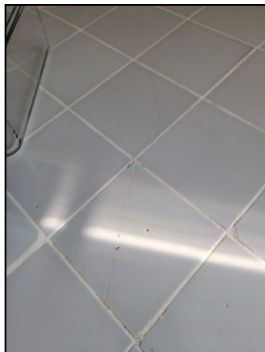
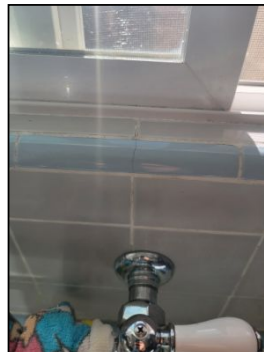
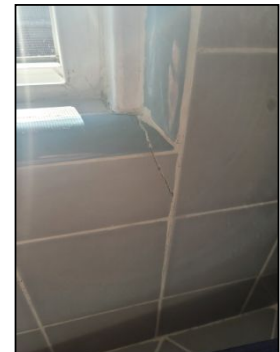
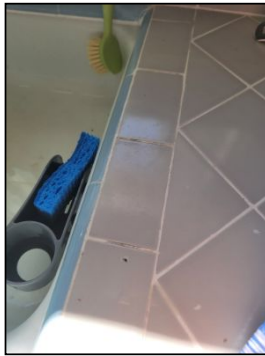
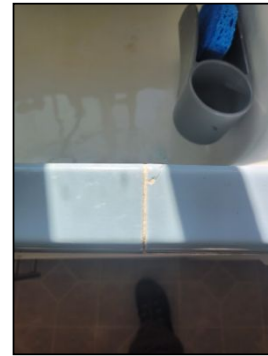
We noted evidence of typical cracking to the counter and back splash tiles, we recommend updating/ repairing as needed.

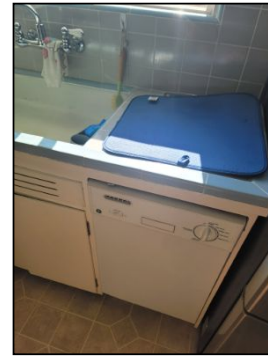
No air gap present. Lack of a proper air gap noted at dishwasher drain line. In the event of a sewer backup this device prevents sewer matter from entering into dishwasher. Recommend having a qualified plumber install a air gap to prevent possible contamination.

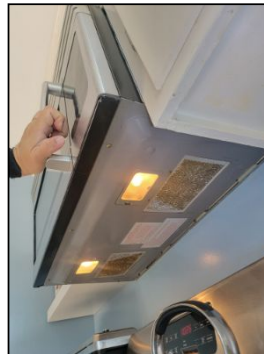
Maintenance Recommendation: Recommend cleaning filter regularly for fire safety.

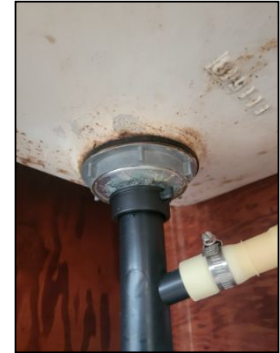
Drain lines showed signs of corrosion however no active leaking was present at the time of inspection recommend monitoring/ repairing/ replacing as needed.

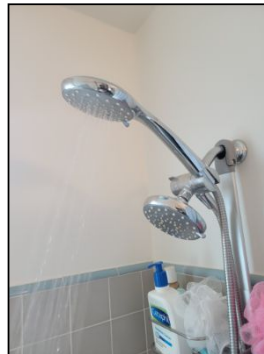
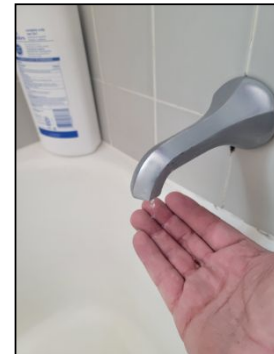
Tub faucet was not properly operating both shower head/ spout were operating at the same time recommend contacting a licensed plumber to repair/ replace as needed.

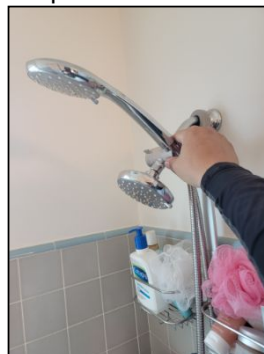
Faucets/ plumbing fixtures were loose recommend properly securing/ repairing/ replacing as needed.

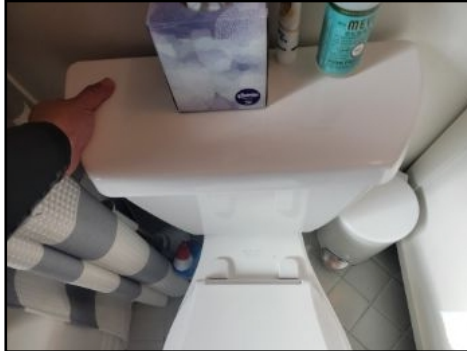
The toilet water tank was loose; we recommend properly securing to prevent potential leaking at the connection point of the toilet water tank and toilet bowl.

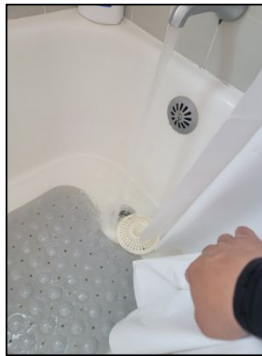
Stopper is inoperable.

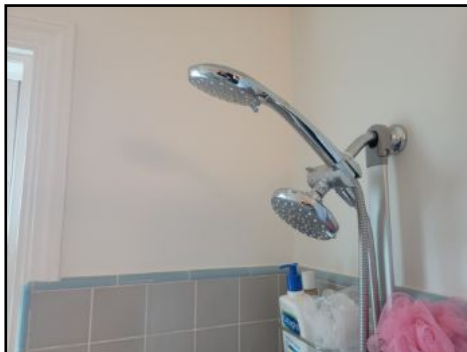
Recommend improving wall covering in the wet areas as needed.

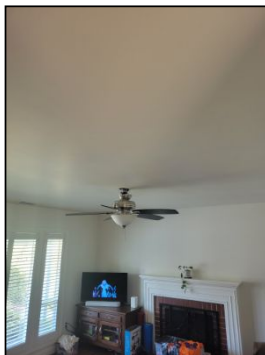
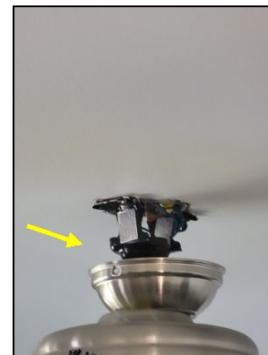
The ceiling fan canopy was not properly installed, recommend repairing/ replacing as needed.

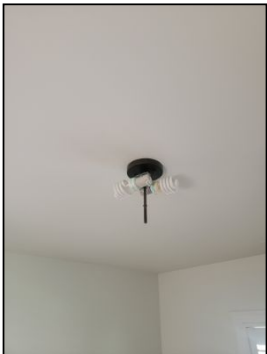
Recommend replacing incomplete light fixtures as needed. Dining Area

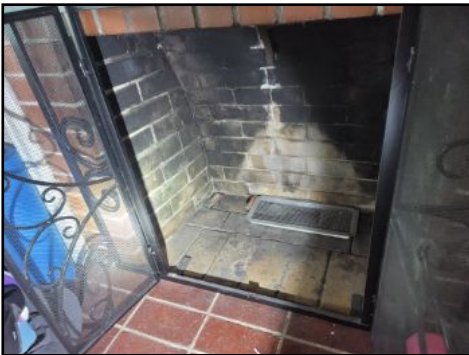
- Recommend replacing damaged clean out cover as needed.
- The damper was not properly operating and/ or the damper was damaged we highly recommend contacting a licensed chimney contractor to repair/ replace as needed.

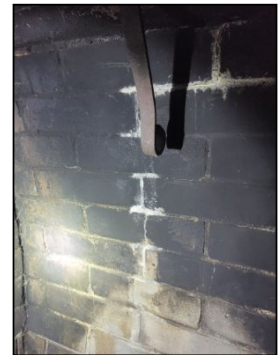
Efflorescence observed within the fireplace; often a sign of water infiltration/exfiltration and can be a precursor of masonry deterioration.

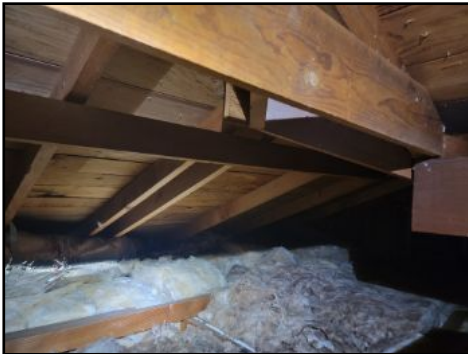
Rafter roof structure was noted at the time of inspection.

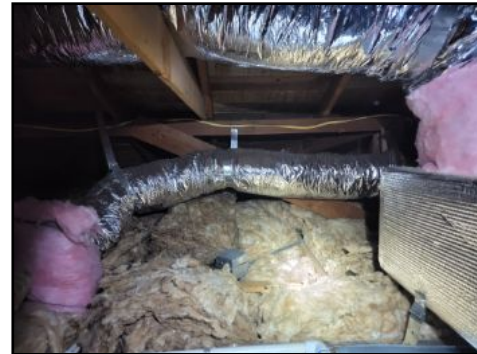
Limited review due to insulation installed between the joist/ framing

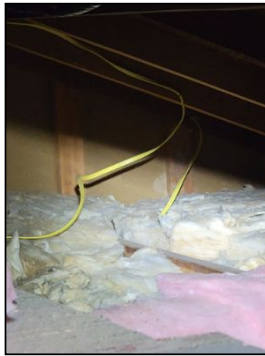
All wiring should be properly secured to the framing.

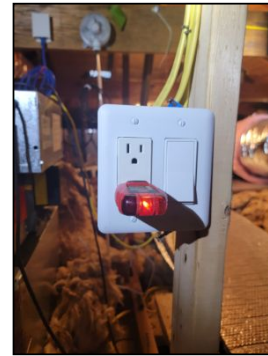
Certain receptacles showed signs of open ground this is noted as a potential hazard recommend repairing/ replacing as needed.

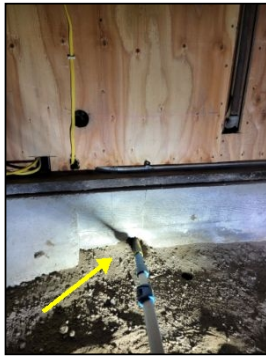
We noted a small section of foundation which was undermined at this area we also noted small cracks due to the undermining. We recommend contacting a licensed professional to improve as needed. Further evaluation of this condition is beyond the scope of this inspection.

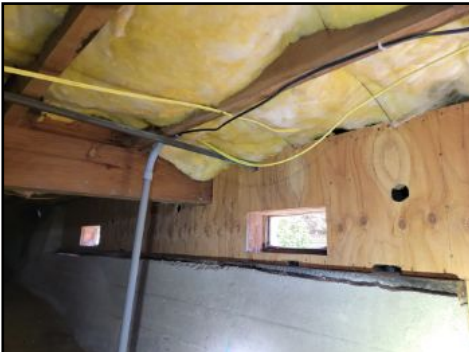
We were unable to perform a complete inspection of the cripple wall this is due to closed walls/ finished surfaces limiting our visibility/ access. Recommend perform periodic inspections as needed.

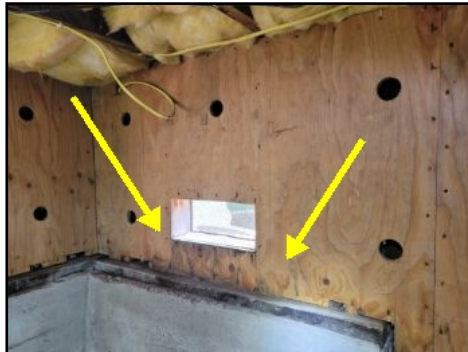
Moisture stains were noted to the shear wall paneling, however, no active leaks noted at the time of inspection recommend monitoring/ repairing/ replacing as needed.

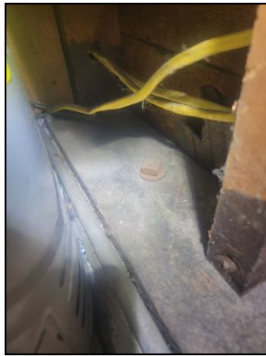
Some of the bolting was outdated.

Bolting is the first step in resisting lateral forces due to wind and seismic activity. We recommend additional bolts be installed in an epoxy bed per current requirements. Bolts should be 5/8 inch thick with square washers, spaced a minimum of 4 feet apart, 12 inches from the end of a sill plate, at least two per board, and embedded at least 7 inches. Contact a licensed general contractor to obtain cost estimates.

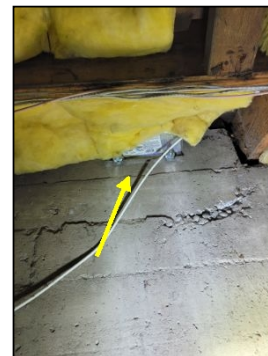
We noted evidence of repaired/ improved anchor bolts/ seismic restrain in the subarea repairs/ improvements appeared to be in overall adequate condition however we do recommend reviewing disclosure/ permit history to understand what was done, and by who. This is noted as a general observation/ recommendation.

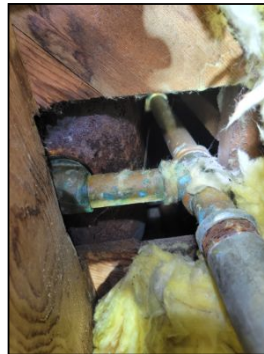
Recommend updating corroded/ leaking drain/ water supply lines as needed.

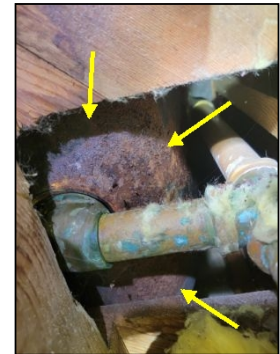
We noted that the tub (below bathroom) had much corrosion and/ or rust. No active leaking was noted at the time of inspection. We do recommend monitoring and/ or periodically inspecting and improving as needed.

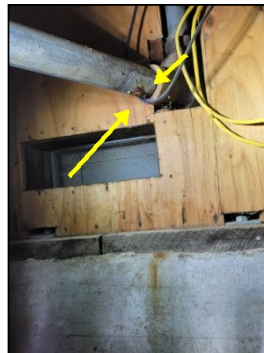
Recommend updating corroded/ leaking drain/ water supply lines as needed.

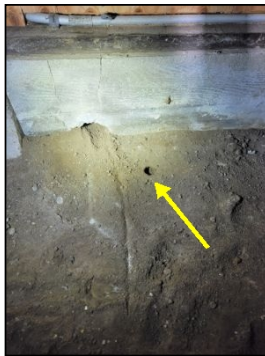
House hold pest type activity was noted in the crawlspace/ floor recommend contacting a licensed Pest Control Operator to mitigate/ clean infestation as needed. Recommend cleaning all debris from the crawlspace floor as needed.

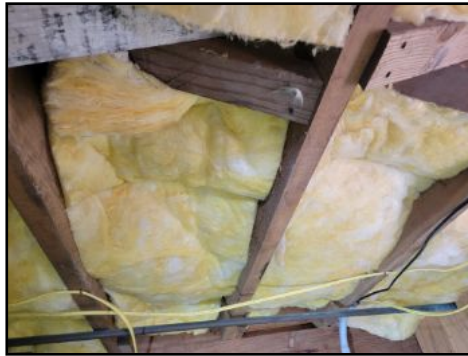
Most of the framing and/ or sub-floor was not visible this is due to the insulation limiting access and/ or visibility. This is noted as information only.

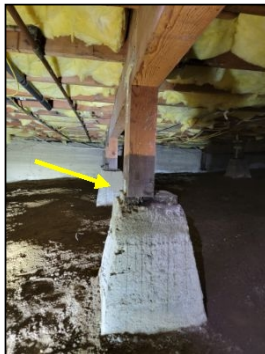
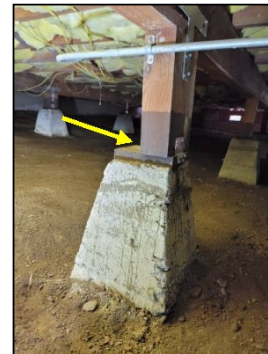
Certain post were not plumb or directly over the pier this is noted as a common construction defect and is mentioned as information only.

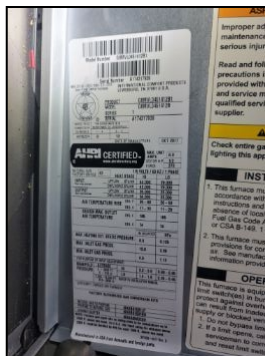
Furnace Dated 10-2017

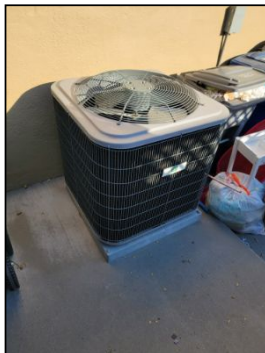
Appeared functional at the time of inspection.

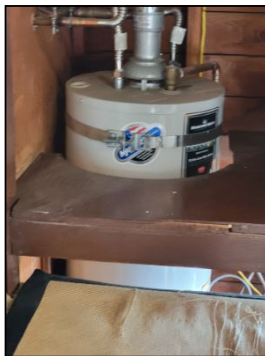
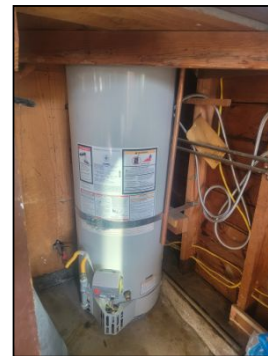
The water heater access location had restrictions (landing build around the water heater) this condition not only limits the required landing space it also will create complications when the water heater needs to be replaced. We recommend contacting a licensed contractor to repair/ improve as needed.

Recommend having the water heater serviced by a licensed plumber as needed.

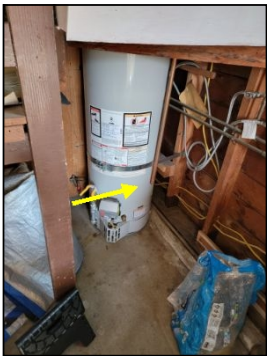
- A Temperature Pressure Relief Valve (**TPR Valve**) present. This safety valve releases water (and thus relieves pressure) if either the temp or pressure in the tank gets too high. The TPR valve discharge tube must be made of copper, iron, or CPVC (NOT regular **PVC**). It must terminate within 6" above the floor--the end cannot be threaded or have a fitting.
- **Temperature-Pressure relief valve extension needs to be 4"-6" off of the floor - this is a Safety Concern.**

Temperature-Pressure relief valve extension needs to be 4"-6" off of the floor - this is a Safety Concern.

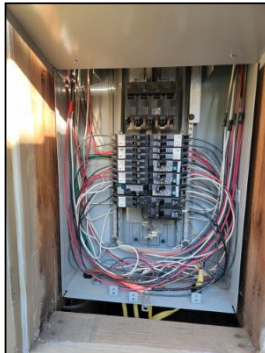
Main Panel (Cover off)

- No major system safety or function concerns noted at time of inspection at main panel box.
- No major system safety or function concerns noted at time of inspection at sub panel box.
- **Please be advised we observed older panels in the garage which were converted to junction boxes. This is noted as a typical alteration however the old panels should be labeled as junction boxes and the covers need to be properly secured (screw). The current condition of these units are noted as a potential safety hazard (not labeled, cover not secured) recommend improving/ updating as needed.**

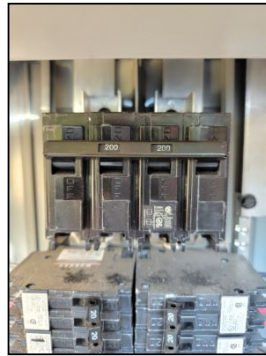
200 amp

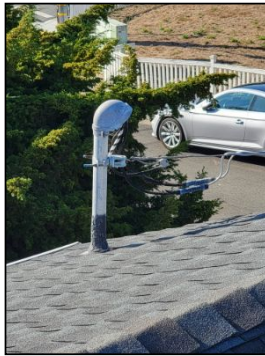
There is an overhead service drop noted.

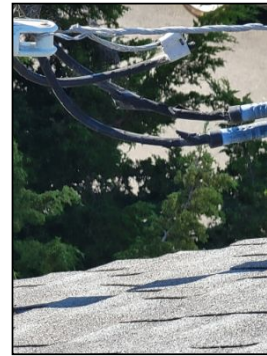
Service feed conduits were in need of normal maintenance recommend contacting a licensed profession to improve/ maintain as needed.

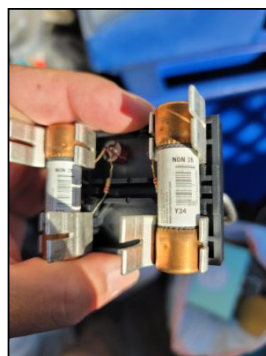
No major concerns were noted at the time of inspection.
