Property Inspection Report

849 Sample St , San Francisco , CA 94114 Inspection prepared for: Real Estate Agent: Sample Sample - Sample Real Estate

Date of Inspection: 10/18/2022 Time: 1:00 PM Age of Home: Built 1960/ 62 Years of Age Size: Approx: 4,854 Sq. Ft. Inspector: Chester R. Gavarrete Jr.

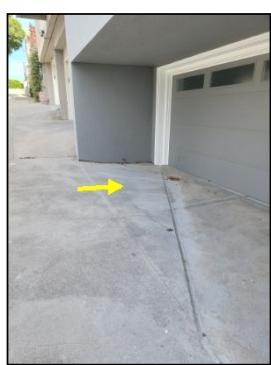
Grading was pitched towards the home this condition is due to the natural slope of the land scape of the area recommend monitoring and maintaining drainage as needed.

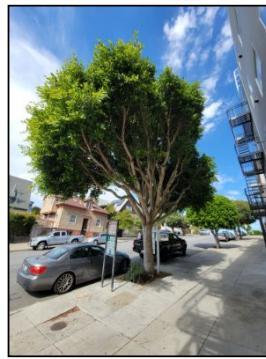
Party of interest should consider consulting with a licensed arborist to review/ inspection any large trees located on the property lot/ perimeter as needed.

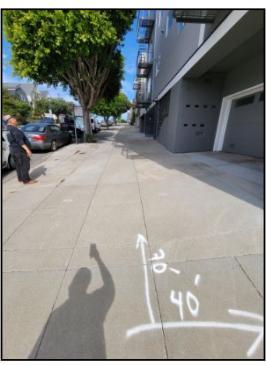
Typical cracking was noted to the driveway/ walkway repair/ replace as needed.

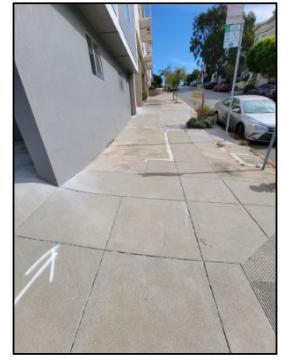
Typical cracking was noted to the driveway/ walkway repair/ replace as needed.

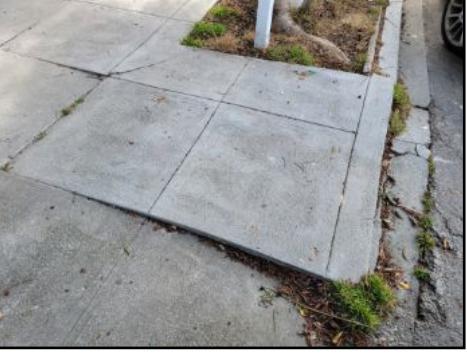
Uneven walkway may pose a potential safety/ trip hazard repair/ replace as needed.

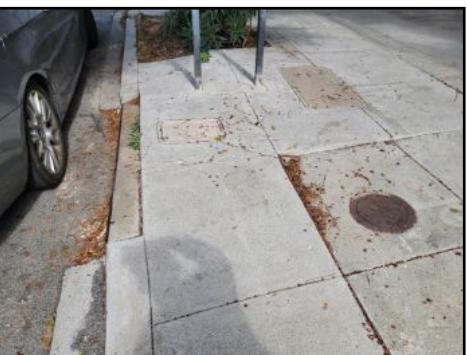
Uneven walkway may pose a potential safety/ trip hazard repair/ replace as needed.

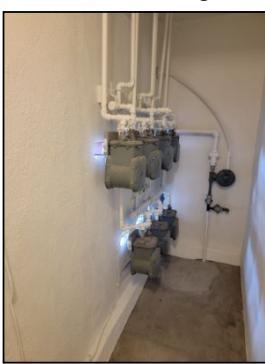
Main gas shut off valve. (Building)

Recommend contacting the Local Utility company to service the Gas meter and related components as needed this is mentioned as information only and is considered part of normal maintenence.

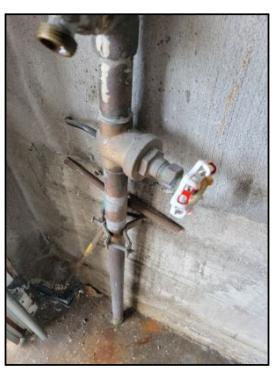
Valve was in overall serviceable condition at the time of inspection.

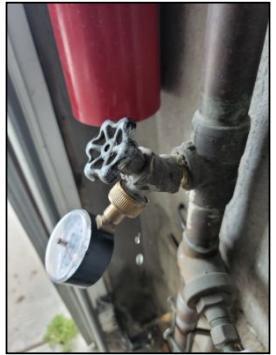
Hose bib(s) not equipped with antisiphon devices, possible crosscontamination. Recommend licensed plumber install as needed.

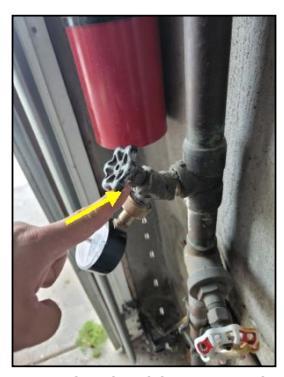
Appears to be leaking at valve seal when in the open position, recommend repair for water conservation and to prevent possible water damage to structure/water intrusion if the hose is left on for extended period.

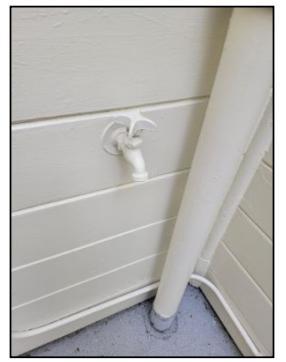
Appears to be leaking at valve seal when in the open position, recommend repair for water conservation and to prevent possible water damage to structure/water intrusion if the hose is left on for extended period.

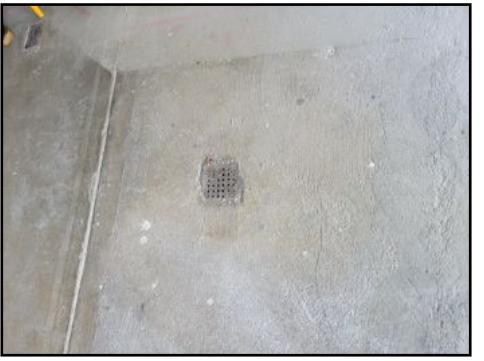
Recommend contacting a licensed plumber/ drainage contractor to service and test the exterior drains to confirm proper functionality.

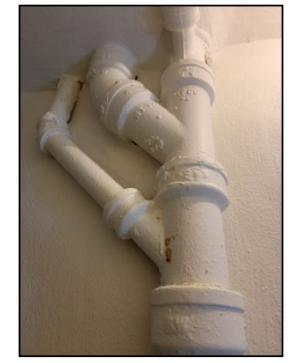
Rust and minor leaking was noted to the grounds plumbing components recommend contacting a licensed plumber to service/ repair/ replace as needed.

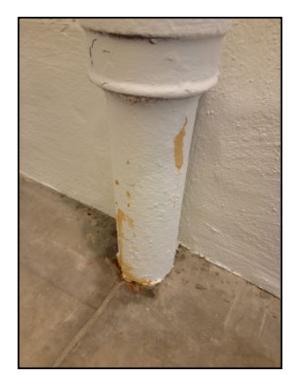
Rust and minor leaking was noted to the grounds plumbing components recommend contacting a licensed plumber to service/ repair/ replace as needed.

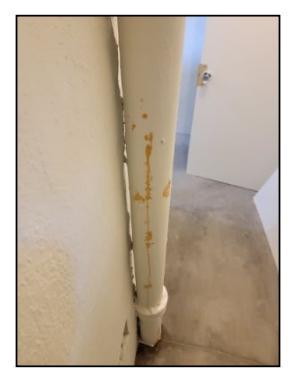
Rust and minor leaking was noted to the grounds plumbing components recommend contacting a licensed plumber to service/ repair/ replace as needed.

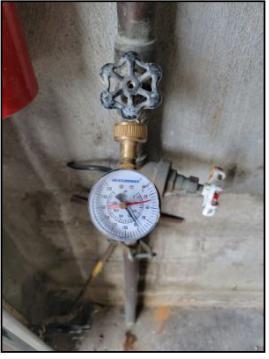
75-80 PSI

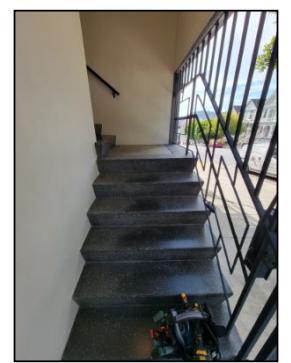
Railing and/ or certain sections of graspable handrail/ grab bar; this condition is noted as a common condition, however, it is noted as a potential safety hazard/ concern we recommend considering improving as needed.

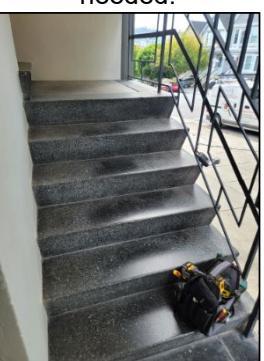
Please note the front steps type are known to be susceptible to water intrusion; we recommend periodically monitoring and servicing as needed.

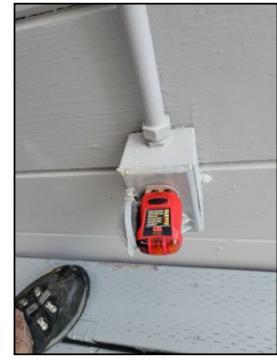
Receptacle was not operating recommend contacting a licensed electrician to repair/ replace as needed.

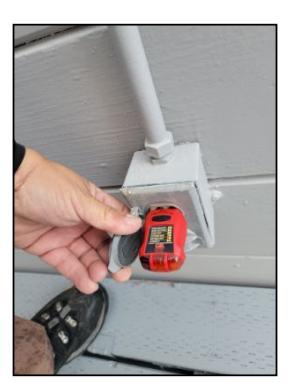
Exterior cover plate was loose, recommend properly securing/ improving as needed.

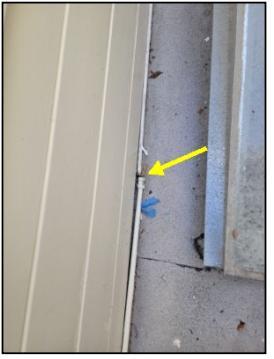
Junction box was missing knock outs this is noted as a potential hazard repair/ replace as needed.

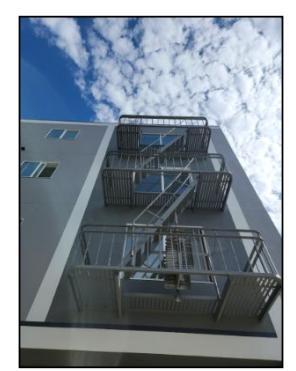
Recommend having the fire escape ladders tested and/ or serviced by a licensed professional as needed; this is noted as a maintenance recommendation.

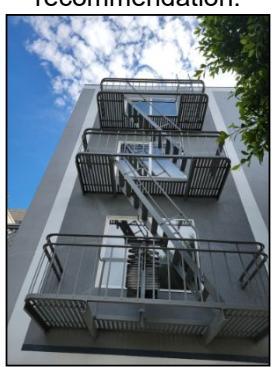
Recommend having the fire escape ladders tested and/ or serviced by a licensed professional as needed; this is noted as a maintenance recommendation.

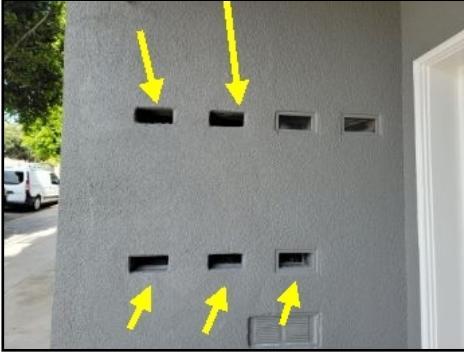
Recommend replacing missing utility opening window pane(s) as needed.

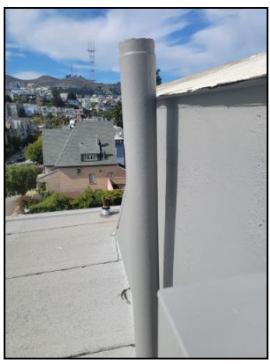
• Vent extension at the roof top was loose and/ or not properly secured, we recommend repairing/ improving this condition as needed.

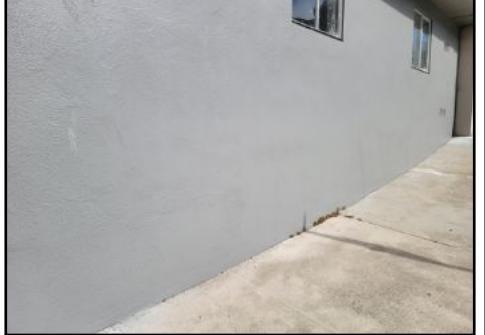
Stucco siding was missing a proper weep screed this is noted as a typical condition for homes of this area and of this age and is mentioned as information only.

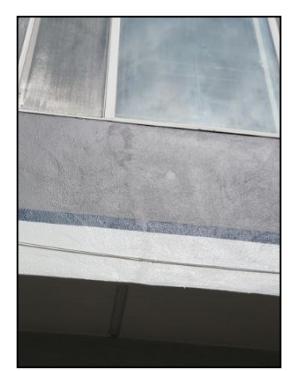
Exterior stucco showed signs of typical cracking recommend sealing/ monitoring/ repairing/ replacing as needed.

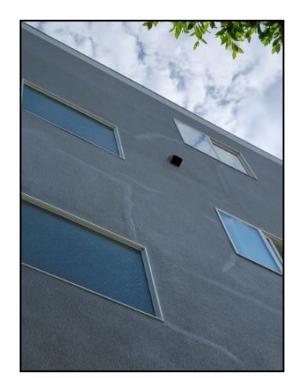
Due to the numerous amounts of cracks/ sealed cracks/ repairs noted at the exterior wall, we recommend periodically monitoring and maintaining as needed. Party of interest should also monitor the interior walls during inclement weather as needed.

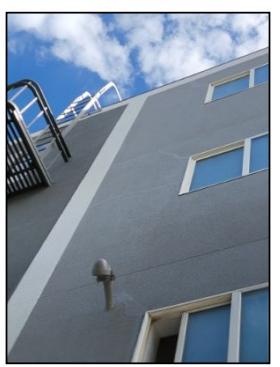
Exterior stucco showed signs of typical cracking recommend sealing/ monitoring/ repairing/ replacing as needed.

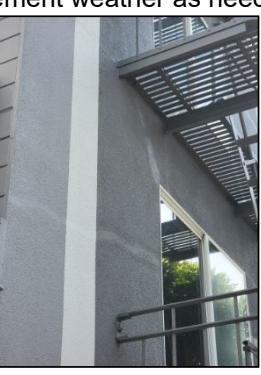
Due to the numerous amounts of cracks/ sealed cracks/ repairs noted at the exterior wall, we recommend periodically monitoring and maintaining as needed. Party of interest should also monitor the interior walls during inclement weather as needed.

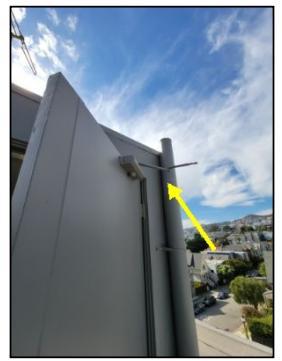
Auto closure mechanism at the roof top properly installed, we recommend contacting a licensed professional to repair/ improve as needed.

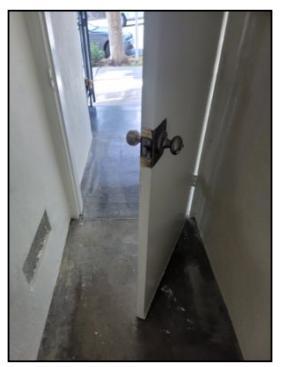
Exterior door showed signs of rotted/ for additional information/ recommendations.

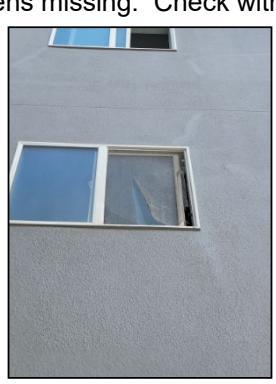
Damaged screen(s) observed, recommend repairing/ replacing as needed.

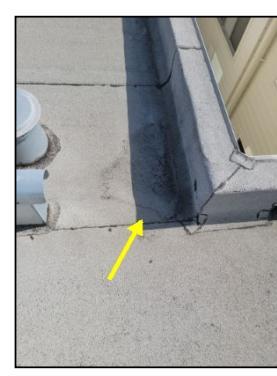
Evidence of ponding noted in some areas this is noted as a sensitive condition recommend monitoring/ repairing/ replacing as needed.

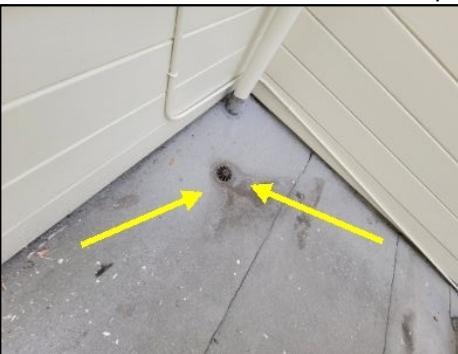
Recommend contacting a licensed plumber/ roofer to properly service/ test roof drains as needed. Testing/ servicing drains should be part of normal maintenence.

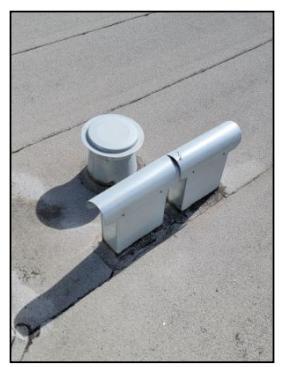
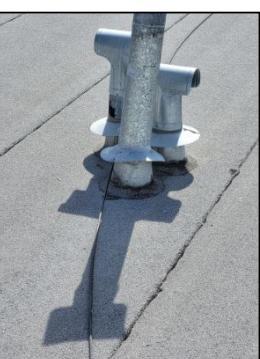
Flashings are mastic covered, recommend re-sealing all through the roof vents and projections as a part of routine maintenance.

Typical maintenance necessary, now and on an annual or semi-annual basis. This generally consists of resealing gaps at through-the-roof projections and at the parapet walls as necessary.

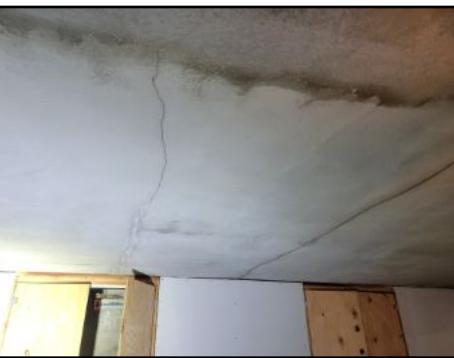
Typical cracking was noted to the wall covering and/ or ceiling recommend repairing/ replacing as needed.

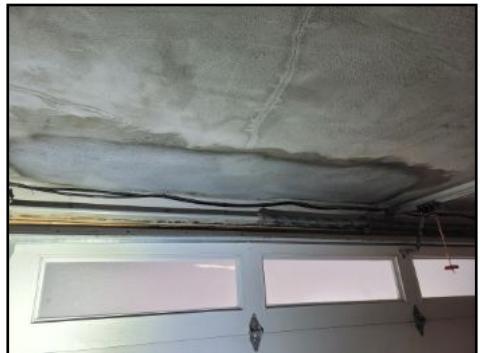
Evidence of repairs were noted at the time of inspection this is noted as general information only.

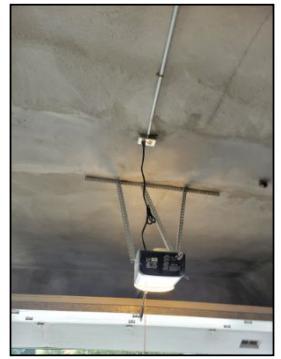
Minimal amount of receptacles were present at the time of inspection this is a common condition for properties of this age and in this area recommend considering adding/ improving as needed.

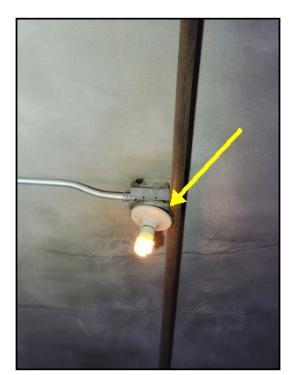
We noted a light fixture installed in a substandard manner/ not fully secured due to inadequate clearance to the adjacent plumbing line. We recommend improving/ repairing as needed.

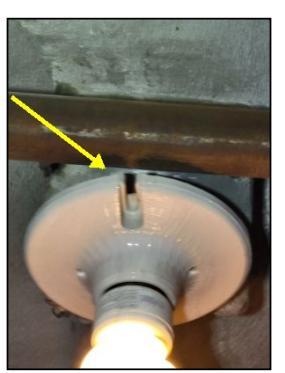
We noted a light fixture installed in a substandard manner/ not fully secured

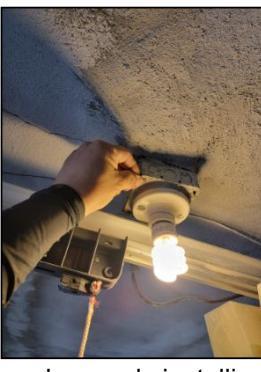
Electrical box was loose recommend properly installing/ repairing/ replacing as needed.

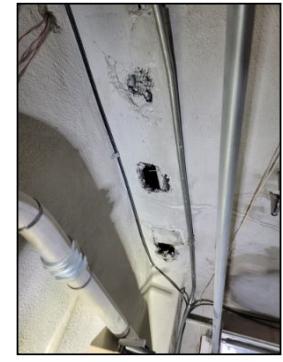
The common wall between the garage and home has damage or improper covered areas. Fire potential to the home is at a greater risk. Recommend repairing or installing the proper fire rated wall.

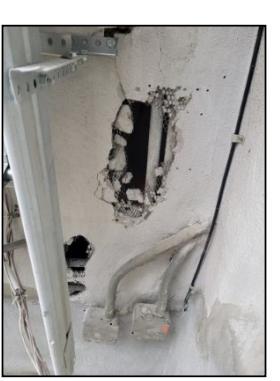
The common wall between the garage and home has damage or improper covered areas. Fire potential to the home is at a greater risk. Recommend repairing or installing the proper fire rated wall.

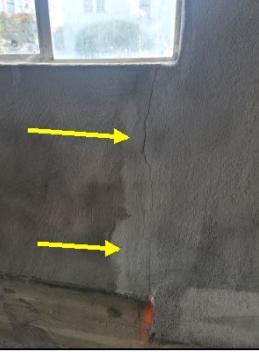
Typical cracking was noted to the wall covering and/ or ceiling recommend repairing/ replacing as needed.

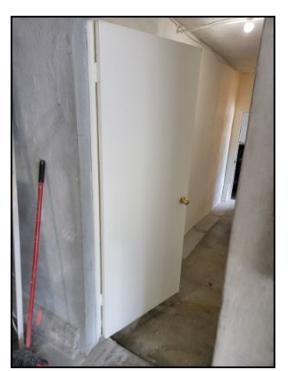
The door is not fire rated this is noted as a SAFETY HAZARD.

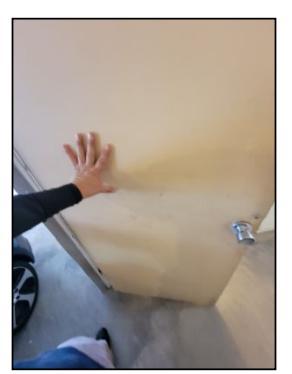
The door is not fire rated this is noted as a SAFETY HAZARD.

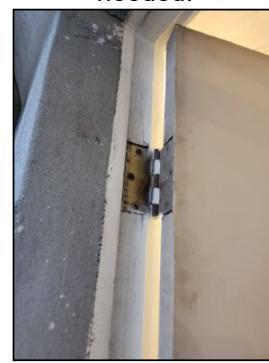
The automatic closure device is missing. This could allow a fire to enter the home and is considered a SAFETY HAZARD. Recommend contacting a licensed door contractor to repair/ replace as needed.

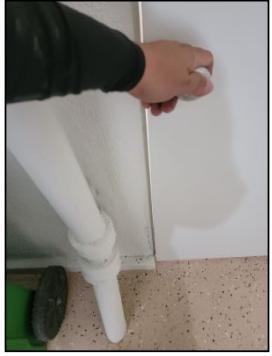
Recommend adjusting the doors and associated components as needed.

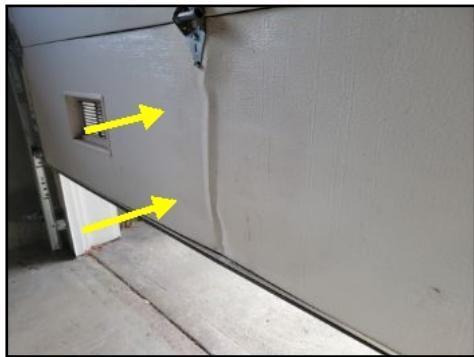
Minor damage was noted to the garage overhead door panel; recommend monitoring and improving as needed.

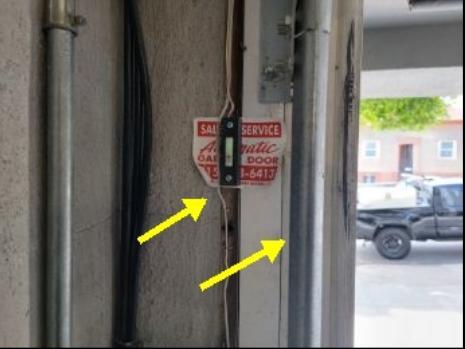
Garage door remote was placed adjacent to the garage door guides/ rails this is noted as a potential safety hazard repair/ replace as needed.

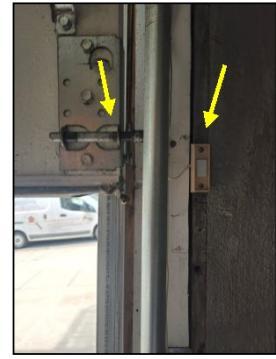
Garage door remote was placed adjacent to the garage door guides/ rails this is noted as a potential safety hazard repair/ replace as needed.

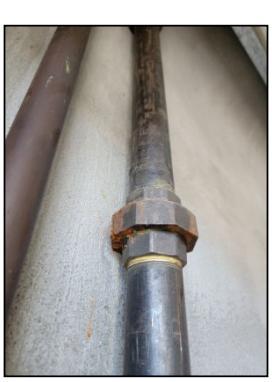
Utility line was exposed to mechanical damage and/ or loose recommend properly securing/ bracing as needed.

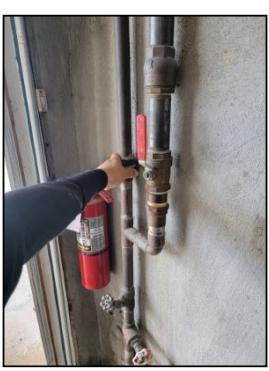
Recommend updating corroded/ rusted water supply lines Utility line was exposed to mechanical damage and/ or loose recommend properly securing/ bracing as needed.

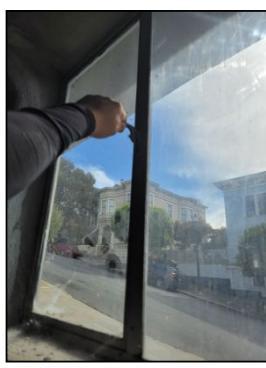
The window servicing the garage was screwed shut and/ or not operating, we recommend contacting a licensed window contractor to improve/ repair as window contractor to improve/ repair as needed.

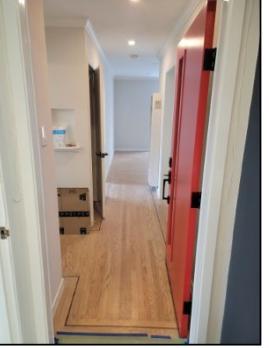
The door between the common area & unit is not a fire rated door. This may not have been required when originally built. Fire doors are fundamental to the integrity of fire barriers which provide resistance to the spread of fire, and smoke. This means that should a fire occur in the common area, this door does not afford protection until firerescue people arrive. This door should be replaced with a fire rated door. This condition is noted as a common condition for homes of this age and in this area.

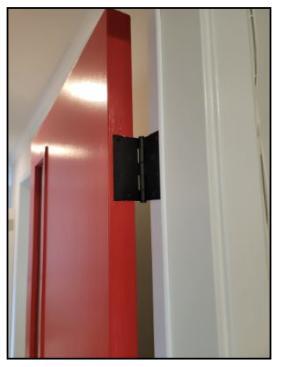
The automatic closure device was missing. This could allow a fire to enter the unit and is considered a SAFETY HAZARD. Recommend contacting a licensed door contractor to repair/ replace as needed.

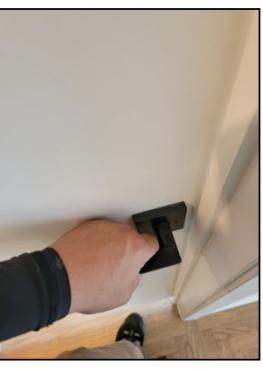
Recommend adjusting door/ components as needed. Unit 1 Bedroom

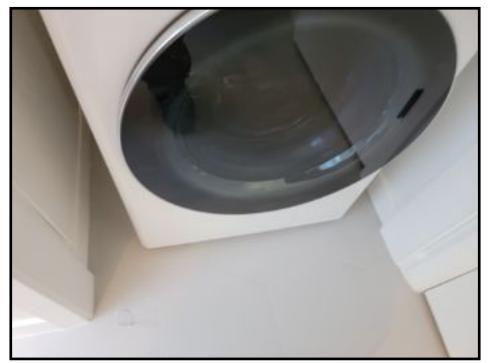
Recommend adding a drain pan for the washer appliance as needed.

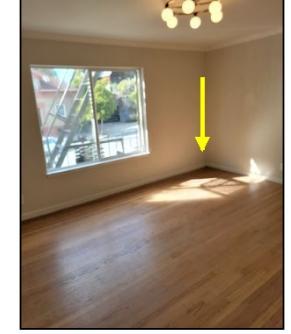
We noted evidence of water/ WDO damage was noted to the flooring in the damage was noted to the flooring in the bedroom refer to the WDO report for additional information and/ or recommendations as needed.

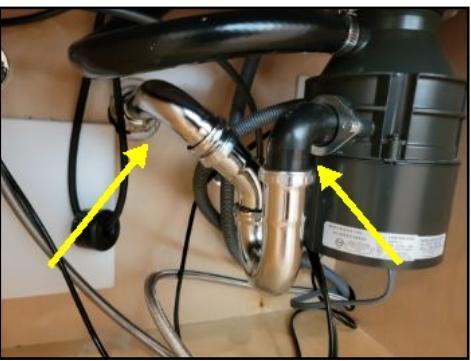
Drain installation was noted as overall poor/ sub-standard recommend contacting a licensed plumber to properly repair/ replace as needed.

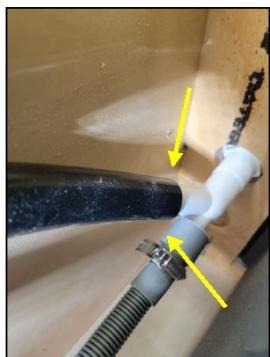
Dishwasher drain line at the air gap was not properly secured, recommend repairing/ improving as needed.

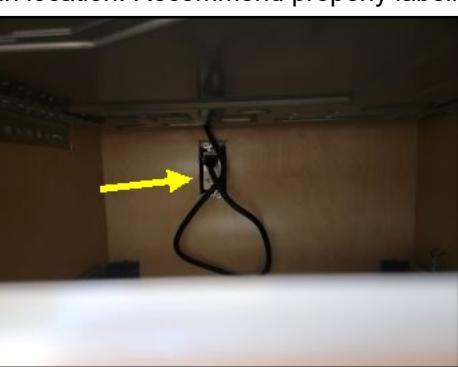
Recommend replacing the missing cover plate(s) as needed.

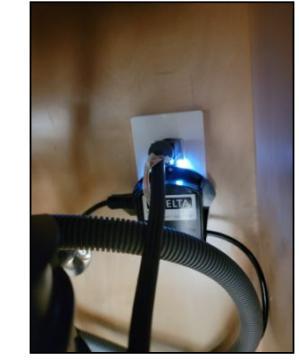
Receptacle under the sink is missing labeling identifying the dishwasher and garbage disposal plug in location. Recommend properly labeling the circuit below the sink as needed.

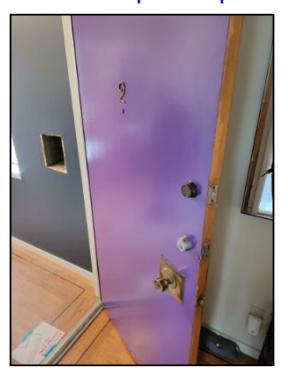
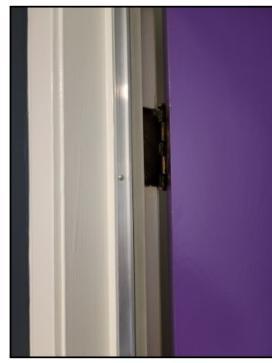
The automatic closure device was missing. This could allow a fire to enter the unit and is considered a SAFETY HAZARD. Recommend contacting a licensed door contractor to repair/ replace as needed.

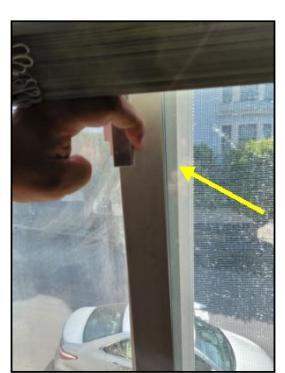
Please be advised we noted that the vinyl window sash/ frame has detached from the window pane, we recommend contacting a licensed window contractor to repair/ improve as needed.

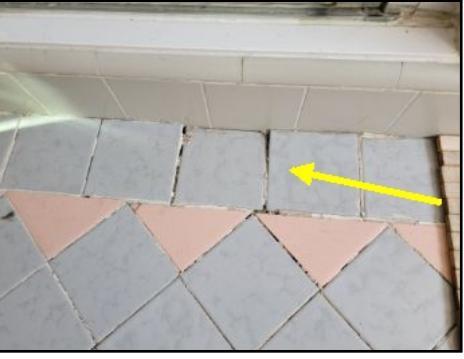
We noted evidence of water damage to We noted evidence of water damage to the flooring outside of the shower (tiled floor/ hardwood floor) refer to the WDO report for additional information and/ or recommendations as needed.

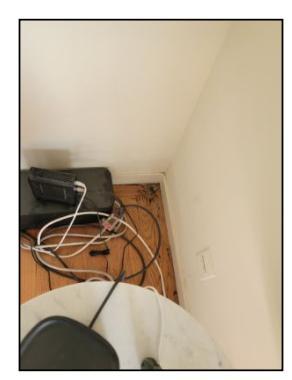
Moisture stains were noted to the flooring in the living room, we recommend contacting a licensed flooring contractor to repair/ maintain this area and we also recommend monitoring this area during inclement weather.

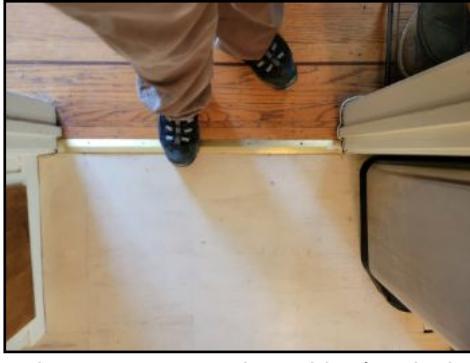
Threshold was loose recommend repairing/ replacing as needed.

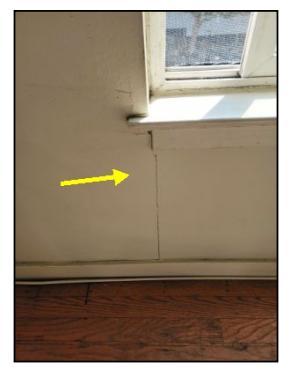
Typical cracking in the wall finish is noted this is mentioned as information for the party of interest.

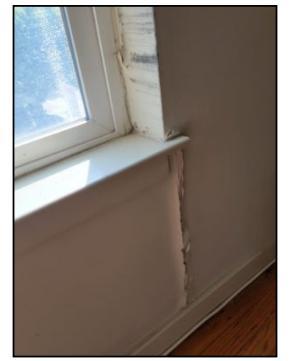
Evidence of moisture stains/ damage was noted on the wall/ceiling. They tested dry at the time of the inspection however we recommend contacting a licensed contractor to further review and repair as needed. We highly recommend monitoring this area during inclement weather.

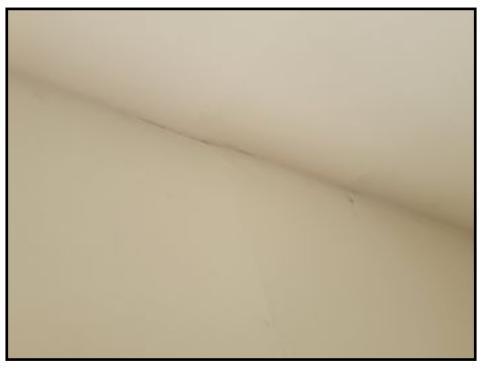
Typical cracking in the wall finish is noted this is mentioned as information for the party of interest.

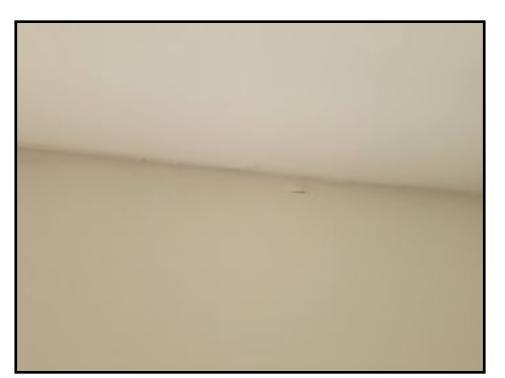
Typical cracking in the wall finish is noted this is mentioned as information for the party of interest.

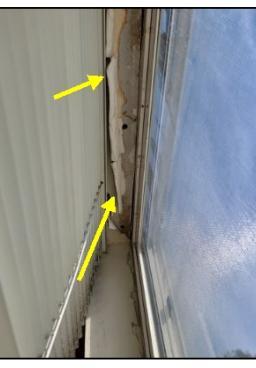
Evidence of moisture stains/ damage was noted on the wall/ceiling. They tested dry at the time of the inspection however we recommend contacting a licensed contractor to further review and repair as needed. We highly recommend monitoring this area during inclement weather.

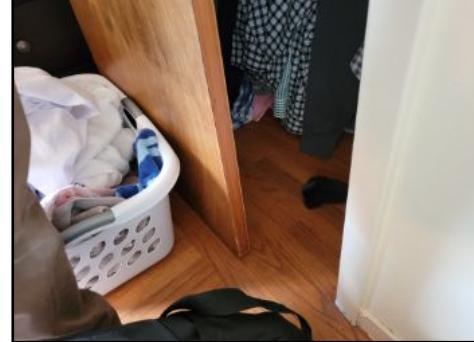
Certain closet doors were missing floor guides recommend adding/ repairing/ replacing as needed.

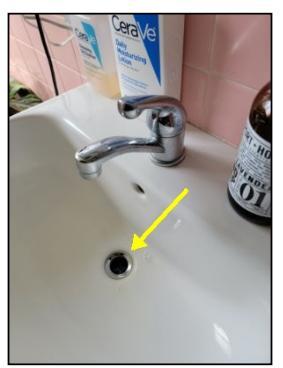
The sink stopper is missing recommend repairing/ replacing as needed.

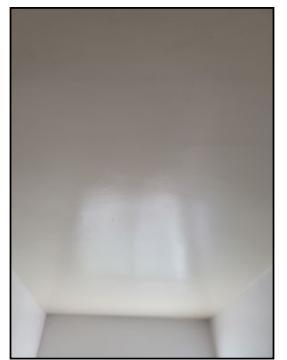
No fan was observed, we recommend an exhaust fan be installed in all bathrooms for proper ventilation and moisture control.

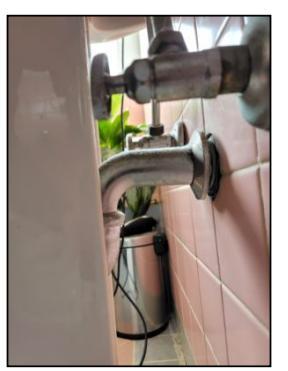
Corrosion was noted around the drain lines, however, no active leaks present at the time of inspection recommend monitoring/ repairing/ replacing as needed.

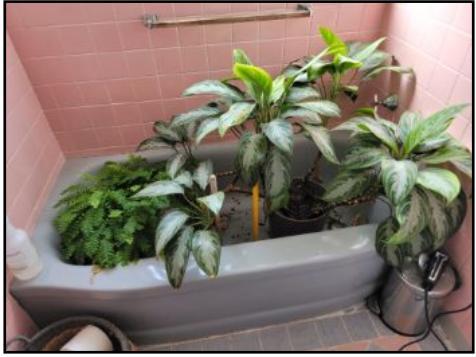
Unable to fully inspect the tub and associated components due to personal property in the tuib at the time of inspection repair/ replace as needed.

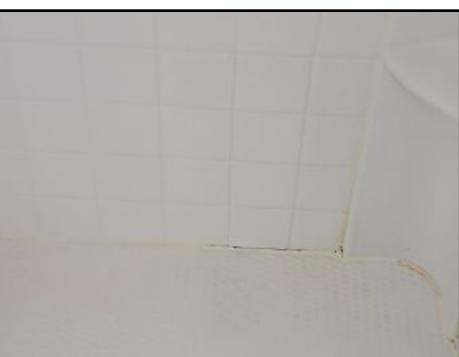
Recommend sealing holes & gaps to stop water infiltration into walls. 15. Bathroom Enclosure Fair Poor N/A Good None Observations: The shower enclosure was functional at the time of the inspection. X 16. Bathroom Electrical Poor Good Fair N/A None Observations: No major system safety or function concerns noted at time of inspection. X 17. Bathroom GFCI Fair Poor N/A None Good Observations: · GFCI in place and operational. X GFCI tested and functioned properly. 18. Rooms Electrical Good Fair Poor N/A Observations: 2-prong outlets -X The home contained outdated, non-grounded 2-prong electrical outlets. Although this condition may have been commonly considered safe or acceptable at the time the home was originally constructed, as general knowledge of safe building practices has improved with the passage of time, building standards have changed to reflect current understanding. Consider updating the existing condition to meet generally-accepted current standards. Some outlets not accessible due to furniture and or stored personal items. It is recommended to avoid use of multiplier outlet plugins (converts 2 into 6 outlets). Bedroom circuits are NOT protected by an arc fault circuit interrupter type breaker. An arc fault interrupter will shut itself off if it detects a short, thus preventing an electrical fire. No Arc-Fault Circuit Interrupter (AFC) protection was installed to protect electrical circuits in bedrooms. Building codes with which new homes must comply require the installation of AFCI protection of all bedroom outlets. This type of protection is designed to detect electrical arcing, which is a potential fire hazard. Although AFCI protection was not required at the time the home was originally constructed, as general knowledge of safe building practices has improved with the passage of time, building standards have changed to reflect current understanding. Consider updating the existing electrical to provide AFCI protection. Arc-fault protection can be provided using either of two methods: 1. Arc Fault Circuit Interrupters (AFCI's) electrical outlets which have this capability built in. 2. AFCI circuit breakers installed at the main electrical panel which provide this protection to all non-AFCI outlets on the circuit controlled by that AFCI breaker. • It is HIGHLY recommended to (have a qualified electrician) install an Arc Fault Circuit Interrupter breaker in place of the the one currently protecting the bedroom circuits. In the near future it will be a requirement and is a very safe and sound update. • Receptacles showed signs of ppen ground; this is noted as a common condition for a home of this age and in this area, however, it is noted as a potential safety concern/ hazard recommend contacting a licensed electrician to repair/ replace as needed.

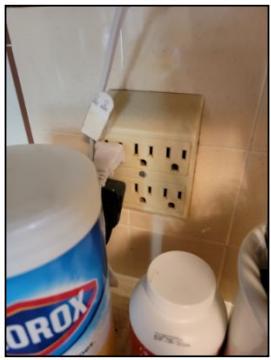
It is recommended to avoid use of multiplier outlet plugins (converts 2 into 6 outlets).

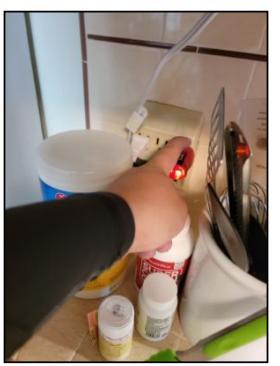
Recommend adding GFCI to kitchen receptacles as needed.

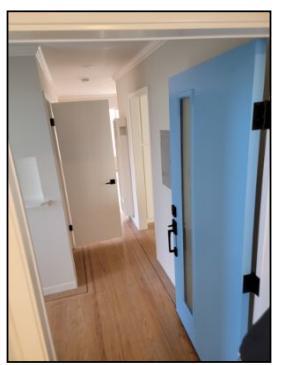
The door between the common area & unit is not a fire rated door. This may not have been required when originally built. Fire doors are fundamental to the integrity of fire barriers which provide resistance to the spread of fire, and smoke. This means that should a fire occur in the common area, this door does not afford protection until firerescue people arrive. This door should be replaced with a fire rated door. This condition is noted as a common condition for homes of this age and in

this area.

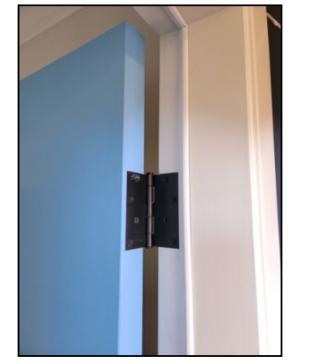
The automatic closure device was missing. This could allow a fire to enter the unit and is considered a SAFETY HAZARD. Recommend contacting a licensed door contractor to repair/ replace as needed.

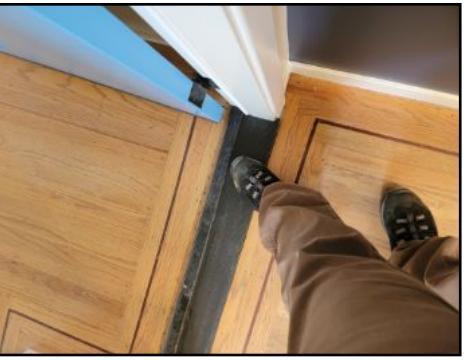
Threshold was loose recommend repairing/ replacing as needed.

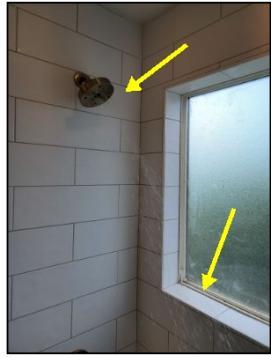
Window height in the tub/ shower area was noted as sub-standard/ low this condition may lead to potential water intrusion/ damage recommend monitoring/ updating/ repairing/ replacing as needed.

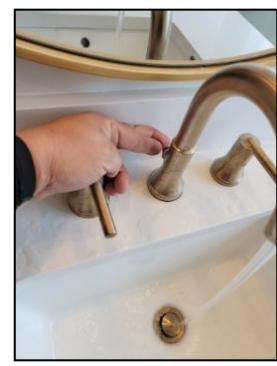
The sink stopper is inoperable recommend repairing/ replacing as needed.

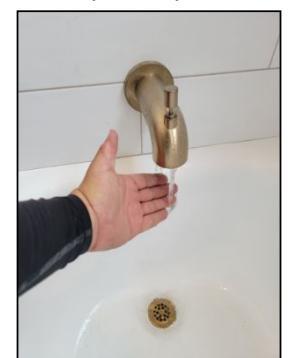
Tub faucet was not properly operating; both shower head/ spout were operating at the same time recommend

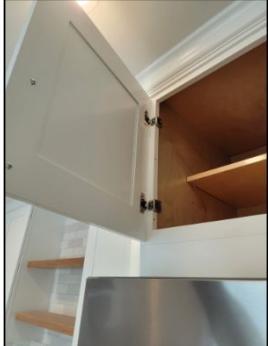
Recommend adjusting/ tightening cabinet hinges as needed.

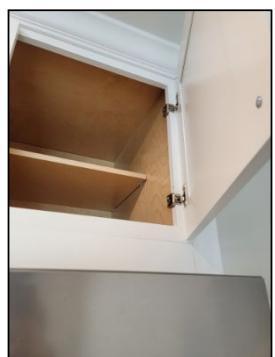
Recommend adjusting/ tightening cabinet hinges as needed.

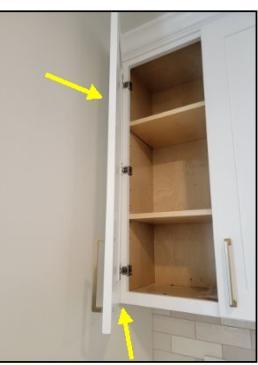
The cabinet door had minimal to poor clearance to the adjacent wall. We recommend monitoring this area and/ or adjusting/ repairing as needed.

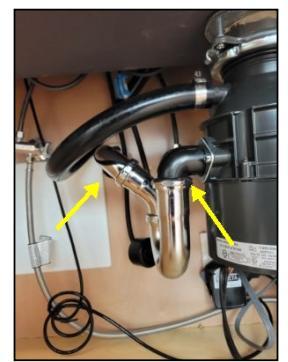
Drain installation was noted as overall poor/ sub-standard recommend contacting a licensed plumber to properly repair/ replace as needed.

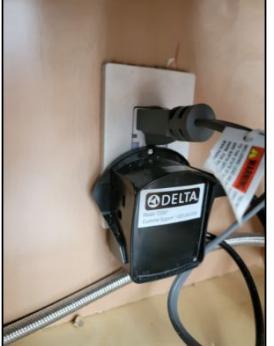
Receptacle under the sink is missing labeling identifying the dishwasher and garbage disposal plug in location. Recommend properly labeling the circuit below the sink as needed.

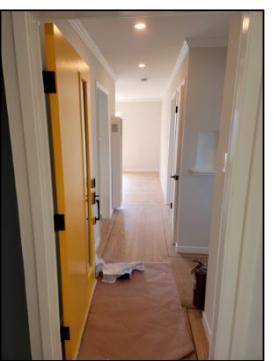
The door between the common area & unit is not a fire rated door. This may not have been required when originally built. Fire doors are fundamental to the integrity of fire barriers which provide resistance to the spread of fire, and smoke. This means that should a fire occur in the common area, this door does not afford protection until firerescue people arrive. This door should be replaced with a fire rated door. This condition is noted as a common condition for homes of this age and in

this area.

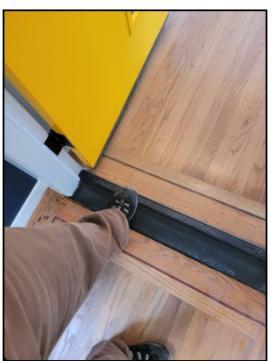
Threshold was loose recommend repairing/ replacing as needed.

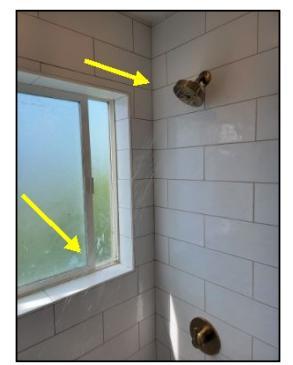
Window height in the tub/ shower area was noted as sub-standard/ low this condition may lead to potential water intrusion/ damage recommend monitoring/ updating/ repairing/ replacing as needed.

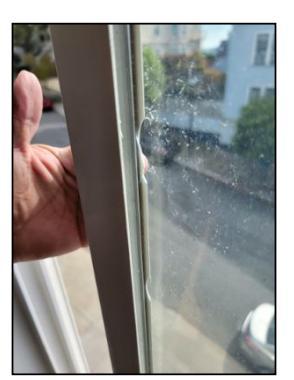
Damaged vinyl windows noted at the time of inspection, we recommend repairing/ improving as needed.

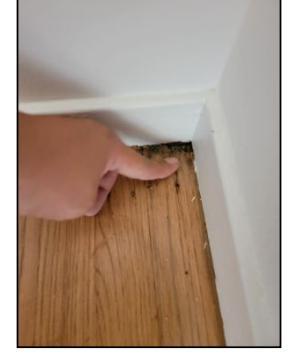
We noted evidence of water/ WDO recommendations as needed.

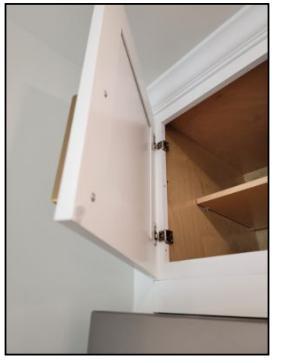
Recommend adjusting/ tightening cabinet hinges as needed.

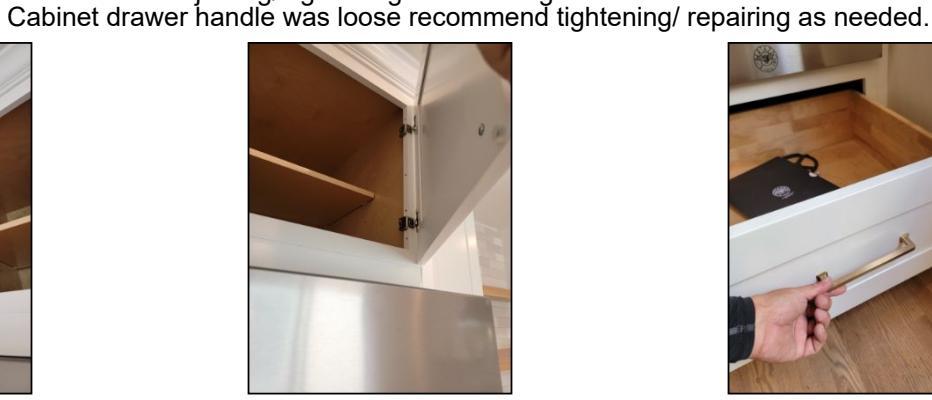
Recommend adjusting/ tightening cabinet hinges as needed.

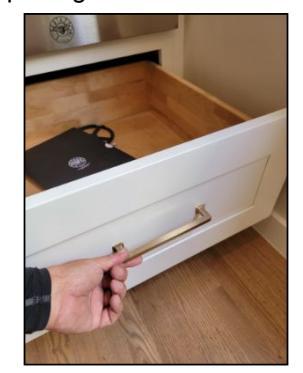
Cabinet drawer handle was loose recommend tightening/ repairing as needed.

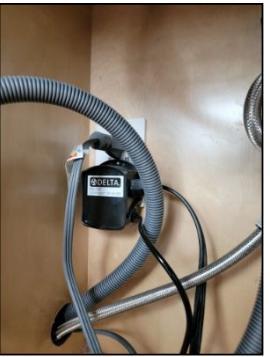
Receptacle under the sink is missing labeling identifying the dishwasher and garbage disposal plug in location. Recommend properly labeling the circuit below the sink as needed.

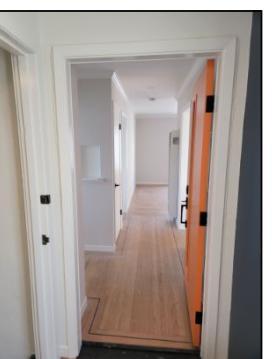
The door between the common area & unit is not a fire rated door. This may not have been required when originally built. Fire doors are fundamental to the integrity of fire barriers which provide resistance to the spread of fire, and smoke. This means that should a fire occur in the common area, this door does not afford protection until firerescue people arrive. This door should be replaced with a fire rated door. This condition is noted as a common condition for homes of this age and in this area.

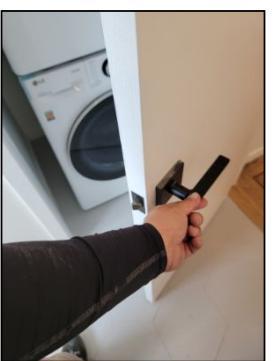
The automatic closure device was missing. This could allow a fire to enter the unit and is considered a SAFETY HAZARD. Recommend contacting a licensed door contractor to repair/ replace as needed.

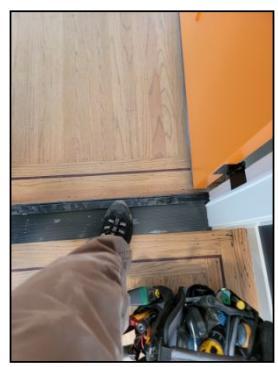
Recommend adjusting door/ components as needed.

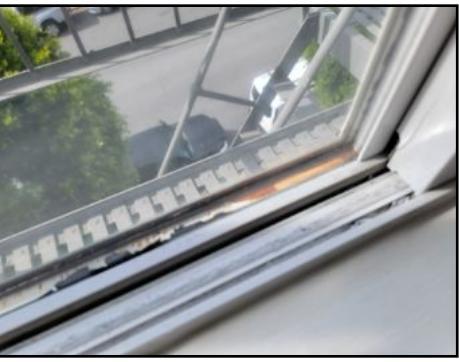
Certain windows showed signs of leaking insulated glass recommend to repair/ further evaluate as needed.

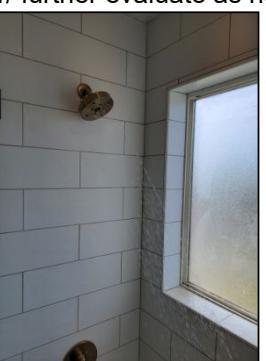
Window height in the tub/ shower area was noted as sub-standard/ low this condition may lead to potential water intrusion/ damage recommend monitoring/ updating/ repairing/ replacing as needed.

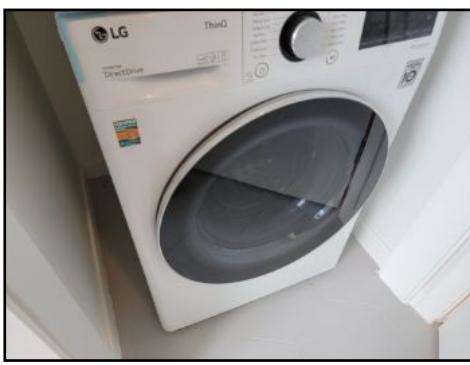
Recommend adding a drain pan for the washer appliance as needed.

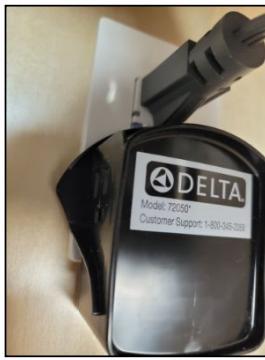
Receptacle under the sink is missing labeling identifying the dishwasher and garbage disposal plug in location. Recommend properly labeling the circuit below the sink as needed.

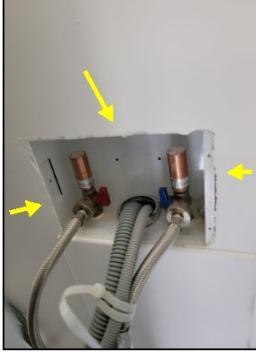
Plumbing recessed box was missing its trim this is noted as a common condition and is mentioned as information only.

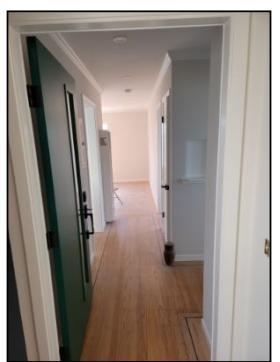
The door between the common area & unit is not a fire rated door. This may not have been required when originally built. Fire doors are fundamental to the integrity of fire barriers which provide resistance to the spread of fire, and smoke. This means that should a fire occur in the common area, this door does not afford protection until firerescue people arrive. This door should be replaced with a fire rated door. This condition is noted as a common condition for homes of this age and in

this area.

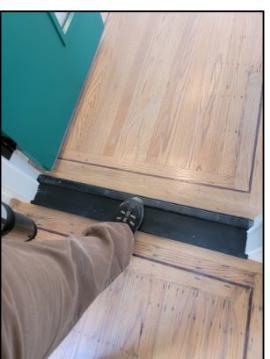
The automatic closure device was missing. This could allow a fire to enter the unit and is considered a SAFETY HAZARD. Recommend contacting a licensed door contractor to repair/ replace as needed.

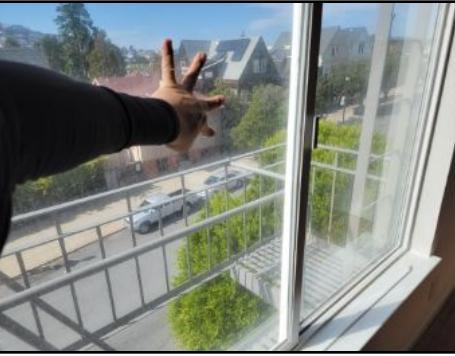
Some windows are very difficult to open, we recommend adjusting/ maintaining the windows as needed.

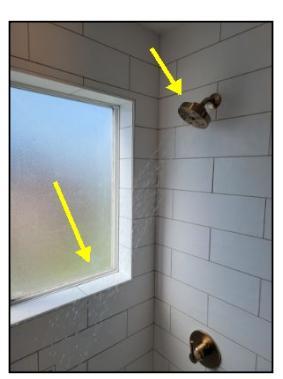
Window height in the tub/ shower area was noted as sub-standard/ low this condition may lead to potential water intrusion/ damage recommend monitoring/ updating/ repairing/ replacing as needed.

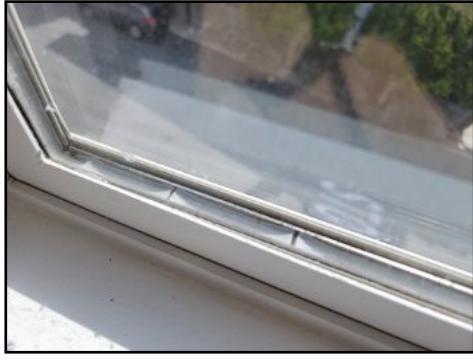
Certain windows showed signs of leaking insulated glass and/ or failed window contractor to repair/ further evaluate as needed.

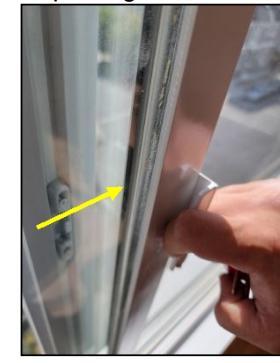
Please be advised we noted that the vinyl window sash/ frame has detached contacting a licensed window contractor to repair/ improve as needed.

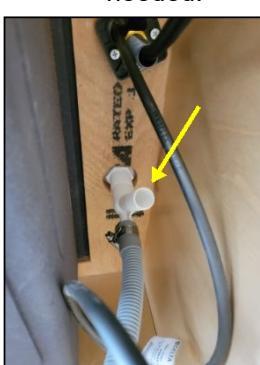
There was a air gap present on the counter however when Dishwasher was not operated this is due to the drain line not inspected from below we noted that the air gap was not connected and/ or not in use; recommend properly installing as needed.

being connected. Recommend testing as needed.

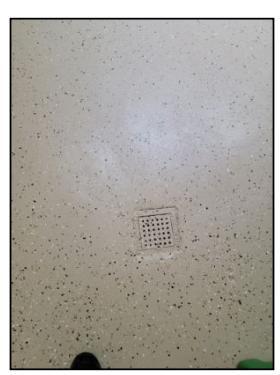
Recommend contacting a licensed plumber/ drainage contractor to service and test the garage drains to confirm proper functionality. (ground floor utility room)

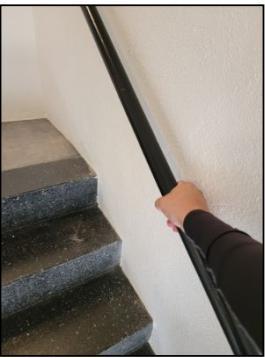
Observations: • Railing was loose and missing a return this is noted as a potential safety hazard recommend contacting a licensed contractor to repair/ replace as needed.

this is noted as a potential safety hazard recommend contacting a needed.

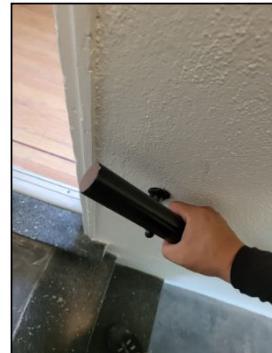
Clean out was slighly protruding from the ground floor (at

the utility room), this condition may lead to a potential trip

hazard, recommend improving/ repairing as needed.

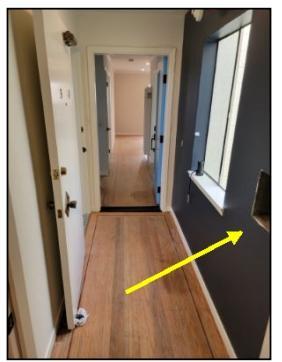
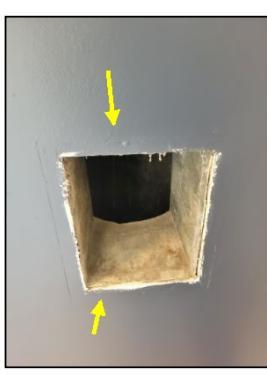
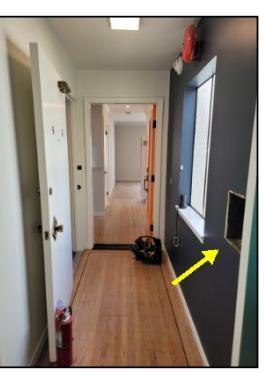
Recommend replacing missing utility door at the common area hallway as needed.

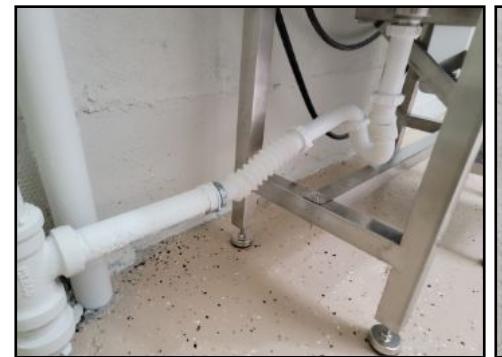
Utility lines were exposed to mechanical damage recommend adding additional bracing/ support as needed.

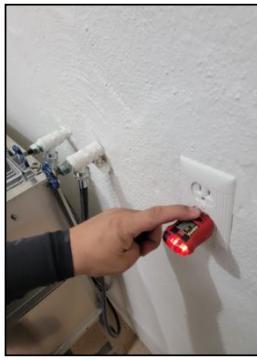
Recommend upgrading All receptacle to GFCI protection within 6 feet of all potential wet locations.

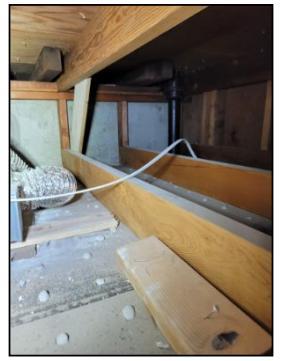
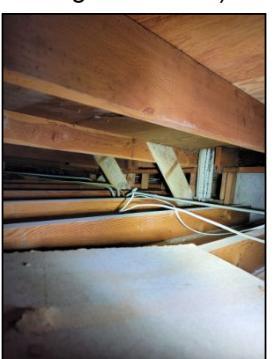
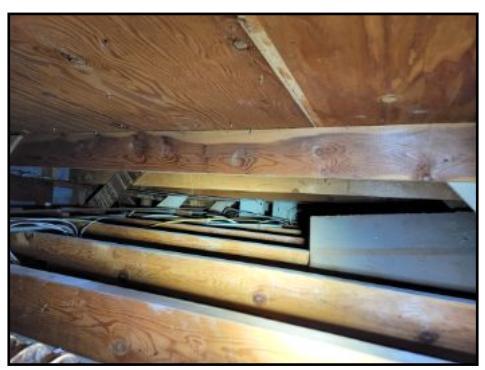
Roof Joist/ Rafter roof structure was noted at the time of inspection.

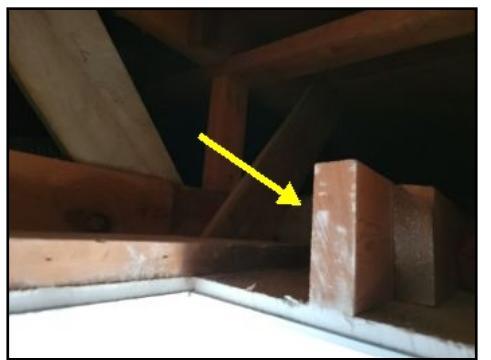
We noted that the ceiling joist were notched to create the attic access hatch opening, we recommend having a licensed professional improve reenforce the joist as needed. licensed professional improve reenforce the joist as needed. (recommend adding blocking as needed)

We noted that the ceiling joist were notched to create the attic access hatch opening, we recommend having a

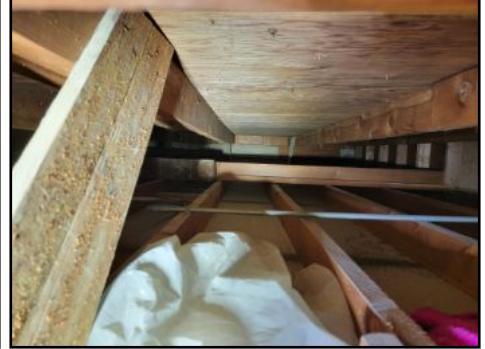
IMPROVE: The attic did not have any insulation. Expect high heating and cooling energy costs. Recommend having the home professionally insulated to reduce energy expenses.

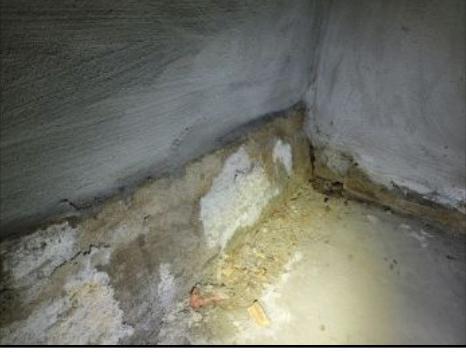
Evidence of WDO infestation was noted at the time of inspection refer to the WDO report for additional information and/ or recommendations as needed.

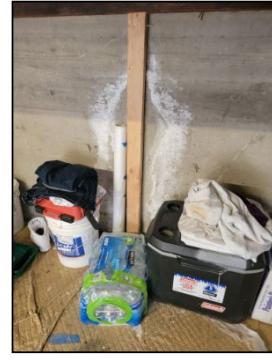
There was a condition known as efflorescence on the foundation walls. This whitish, crystalline or powdery material is a deposit of soluble salts that infiltration. Generally speaking, cracks were originally within the concrete or masonry and were brought to the surface by water traveling through his material. When the water evaporates, the salts are deposited on the surface. Efflorescence, for the most part, is a visual condition and generally does not cause structural problems, however it does indicate an occasional surplus of moisture around the foundation recommend monitoring as needed.

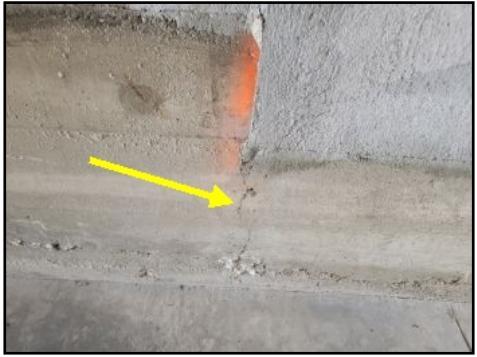
Cracks / Holes (1/4" or less) present in: Cracks / Holes (1/4" or less) present in: foundation / floor / ext. wall. Consider foundation / floor / ext. wall. Consider sealing them to prevent water infiltration. Generally speaking, cracks that are less than 1/4" are not commonly regarded as being structurally significant.
