Property Inspection Report

849 Sample St , San Francisco , CA 94114 Inspection prepared for: Real Estate Agent: Sample Sample - Sample Real Estate

Date of Inspection: 10/18/2022 Time: 1:00 PM Age of Home: Built 1960/ 62 Years of Age Size: Approx: 4,854 Sq. Ft. Inspector: Chester R. Gavarrete Jr.

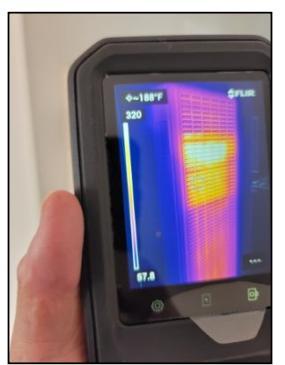
The heating units were in overall normal operating condition however we recommend contacting a licensed HVAC contractor to repair/ service the unit prior to normal use. (Units 3)

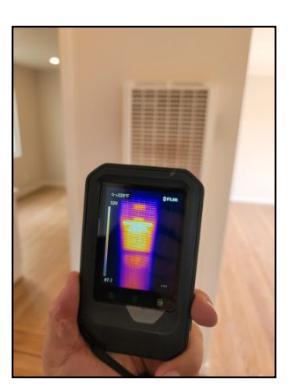
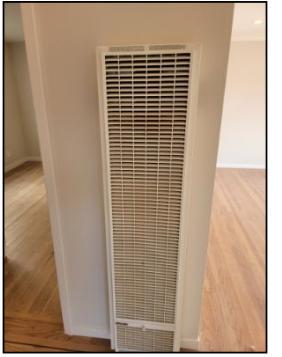
The heating units were in overall normal operating condition however we recommend contacting a licensed HVAC contractor to repair/ service the unit prior to normal use. (Unit 4)

Recommend contacting a licensed HVAC contractor service the furnace prior to normal use as needed. (Unit 4)

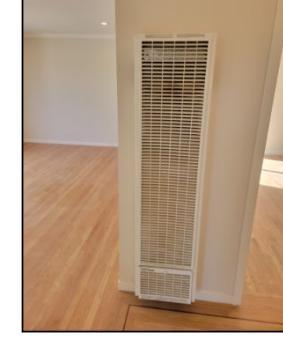
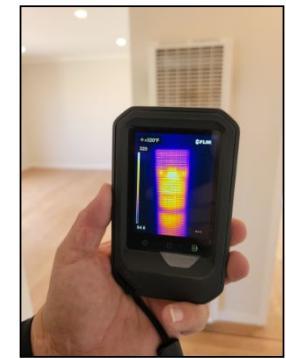
The heating units were in overall normal operating condition however we recommend contacting a licensed HVAC contractor to repair/ service the unit prior to normal use. (Unit 5)

The heating units were in overall normal The heating units were in overall normal operating condition however we recommend contacting a licensed HVAC contractor to repair/ service the unit prior to normal use. (Unit 5)

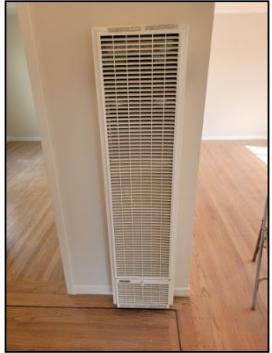
operating condition however we recommend contacting a licensed HVAC contractor to repair/ service the unit prior to normal use. (Unit 6)

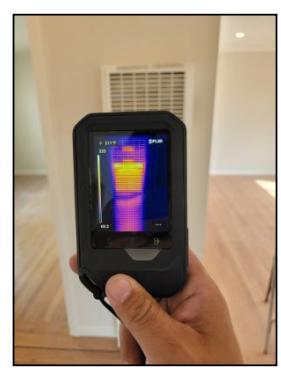
The heating units were in overall normal operating condition however we recommend contacting a licensed HVAC contractor to repair/ service the unit prior to normal use. (Unit 6)

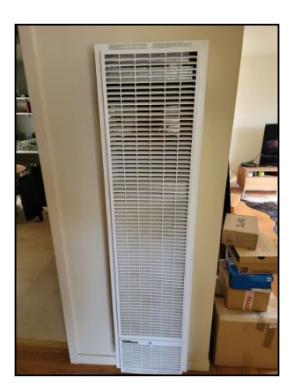
The heating units were in overall normal operating condition however we recommend contacting a licensed HVAC contractor to repair/ service the unit prior to normal use. (Unit 1)

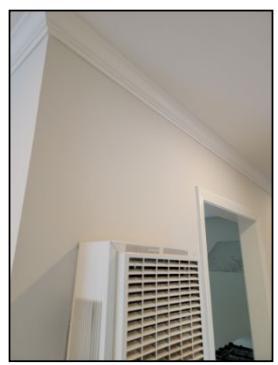
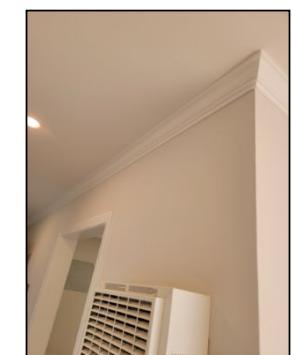
Unable to completely inspect the fireplace flue's this is due to the flue type (concealed in the wall) this is noted as information only. (Unit 1)

Unable to completely inspect the fireplace flue's this is due to the flue type (concealed in the wall) this is noted as information only. (Unit 4)

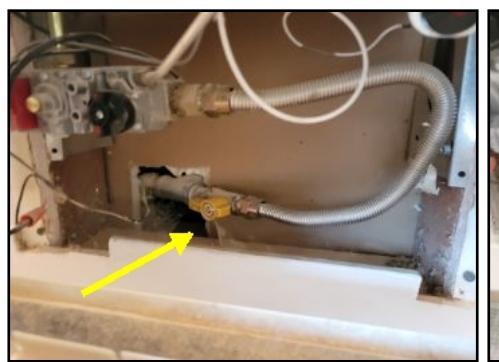
Gas shut off valves were present and

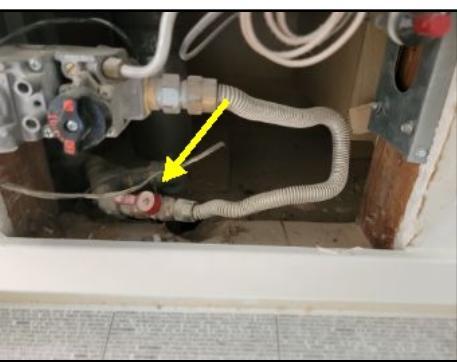
Gas shut off valves were present and functional. (Units 3)

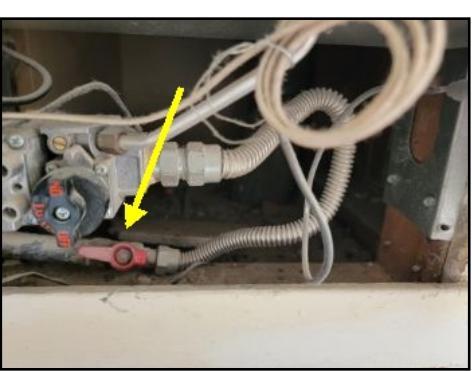
Gas shut off valves were present and functional. (Unit 4)

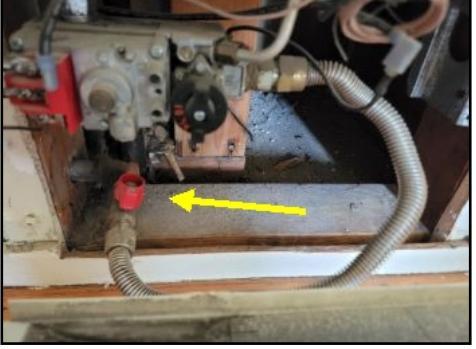
Gas shut off valves were present and functional. (Unit¹)

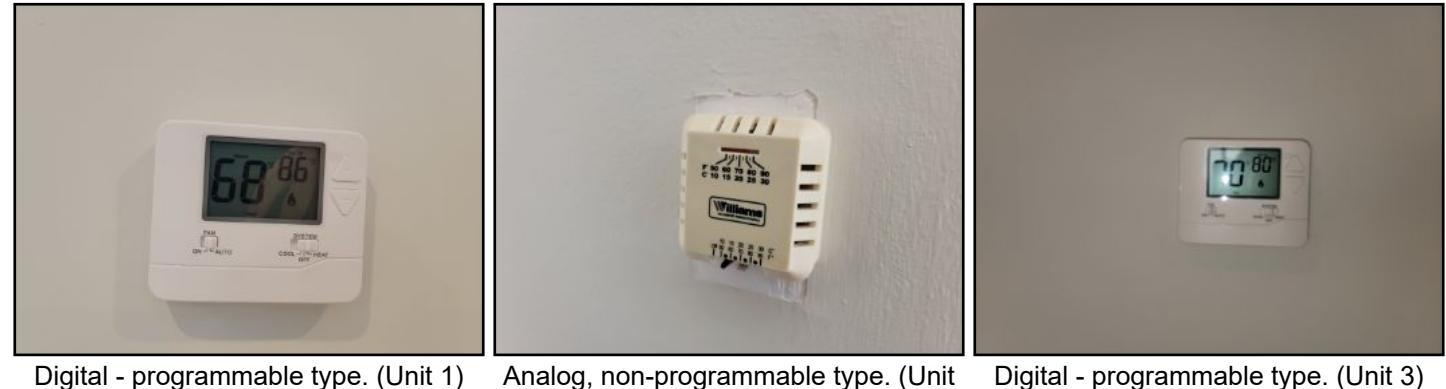
- vations:
- al programmable type. (Units 1, 3-6)
- ctional at the time of inspection.
- Thermostats are not checked for calibration or timed functions.
- Analog, non-programmable type. (Unit 1)
 IMPROVE: Non-programmable thermostats have no energy saving capabilities as do digital setback-type thermostats. Recommend an upgrade to a modern, digital programmable thermostat.

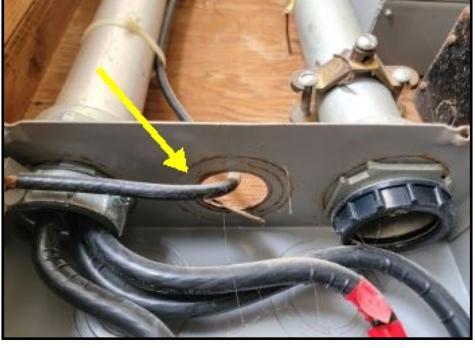
Missing connectors were noted in the sub-panel this is noted as a potential safety hazard recommend repairing/ replacing as needed. Building Main Switch Panel

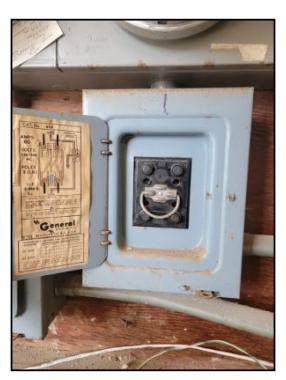
Outdated panel was noted at the time of inspection, no representation is made to inspection we recommend contacting a this area. this area. licensed electrician to repair/ update as needed. Please refer to the web site provided here for further information; http://www.ismypanelsafe.com/outdated .php Due to the panel type our inspection was very limited. Unit 1 Main Panel

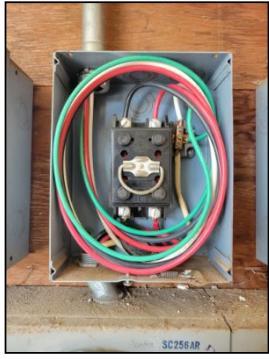
Excess conduits were noted within the unit 2 main panel, we recommend contacting a licensed professional to repair/ improve as needed.

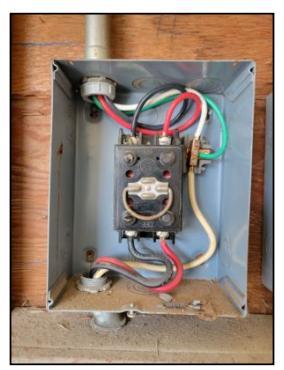
Outdated panel was noted at the time of inspection we recommend contacting a licensed electrician to repair/ update as needed. Please refer to the web site provided here for further information; http://www.ismypanelsafe.com/outdated .php Due to the panel type our inspection was very limited. Unit 4 Main Panel

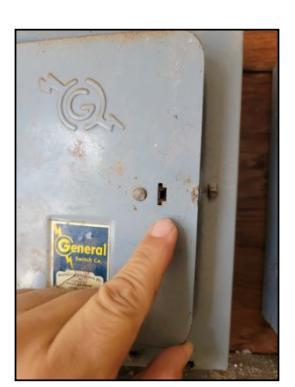
Recommend replacing missing panel latches as needed. Unit 5 Main Panel

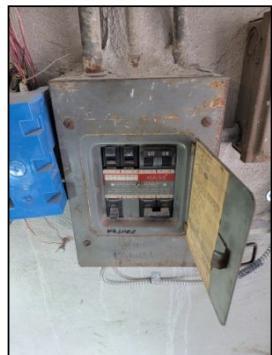
There is a Federal Pacific Electric service panel in the house. There are breakers are prone to problems that can lead to failures, lack of proper protection of circuits and other serious issues, including fire and electrocution. Although the Consumer Products Safety Commission has not issued a formal product recall, the panel is old and the company is now out of business. We cannot definitively call this panel defective, but recommend, for your peace of mind, to consult a qualified electrical contractor to get their opinion on this matter. You can learn more about this issue at: http://www.lsmypanelsafe.com

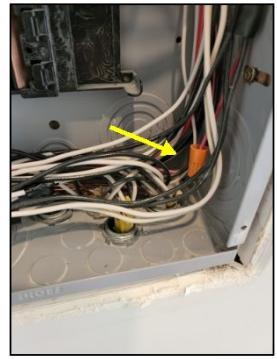
We observed junctions/ terminations performed with in the panels our recommendation is to have all junctions/ terminations performed in a junction box out side of the panel as needed. Unit 4 Sub-Panel

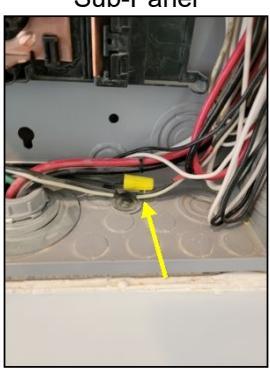
Unit 5 Sub-Panel (Cover off)

We observed junctions/ terminations performed with in the panels our recommendation is to have all junctions/ terminations performed in a junction box out side of the panel as needed. Unit 5 Sub-Panel

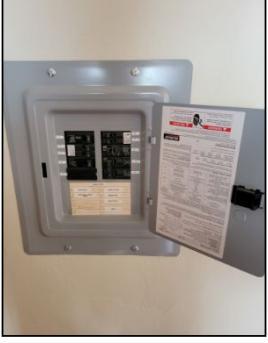
We noted excess gap between certain subpanels and the wall covering, we recommend improving/ repairing this installation as needed. Unit 5 Sub-Panel

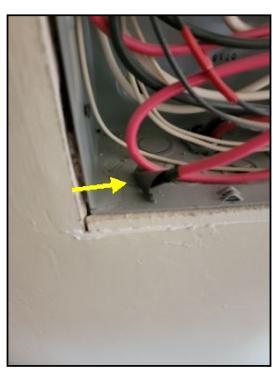
Unit 1 Sub-Panel (Cover off)

We observed junctions/ terminations performed with in the panels our recommendation is to have all junctions/ terminations performed in a junction box out side of the panel as needed. Unit 1 Sub-Panel

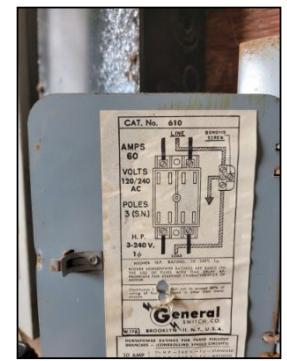
200 amp - Fuse - (Main Switch - Recommend having a licensed electrician further review and provide recommendations for repair/ update)

60 amp (Fuse - Units - Under rated and/ or minimally rated, we recommend having a licensed electrician further review and provide recommendations for a potential update/ repair.)
